Moehle, J.P., Eberhard, M.O. "Earthquake Damage to Bridges."
Bridge Engineering Handbook.
Ed. Wai-Fah Chen and Lian Duan
Boca Raton: CRC Press, 2000

Earthquake Damage to Bridges

Jack P. Moehle

Marc O. Eberhard

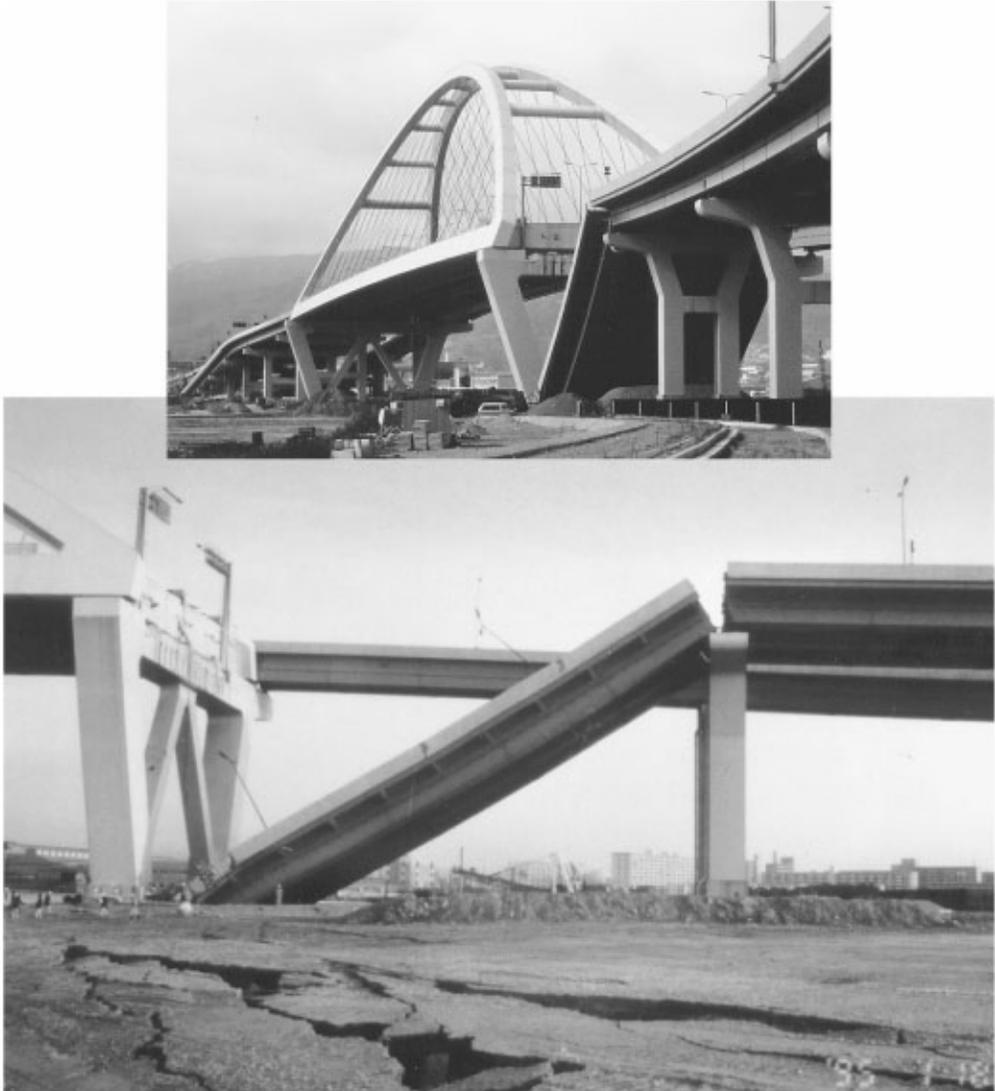
FIGURE 34.3 Nishinomiya-ko Bridge approach span collapse in the 1995 Hyogo-Ken Nanbu earthquake [Kobe Collection, EERC Library, University of California, Berkeley].

Furthermore, many of the sites were subject to liquefaction and lateral spreading, resulting in permanent substructure deformations and loss of superstructure support (Figure 34.3). Finally, the site was directly above the fault rupture, resulting in ground motions having high horizontal and vertical ground accelerations as well as large velocity pulses. Near-fault ground motions can impose large deformation demands on yielding structures, as was evident in the overturning collapse of all 17 bents of the Higashi-Nada Viaduct of the Hanshin Expressway, Route 3, in Kobe (Figure 34.4). Other factors contributed to the behavior of structures in Kobe; several of these will be discussed in subsequent portions of this chapter.

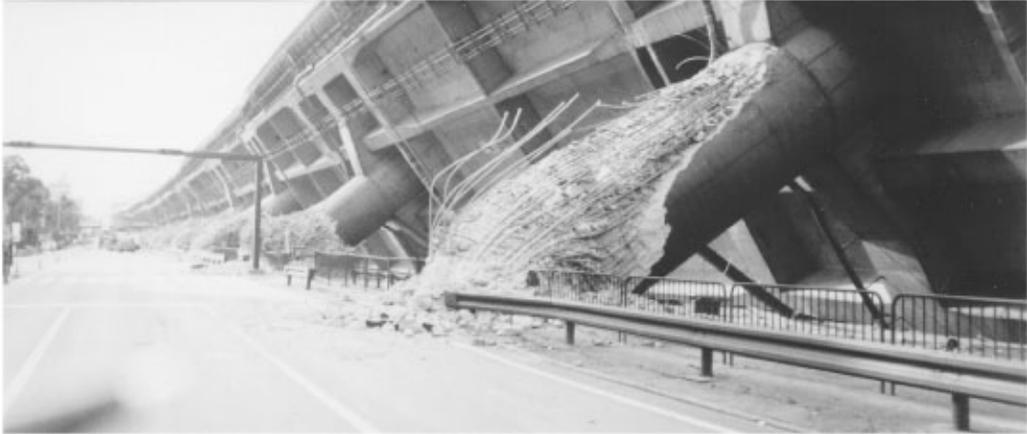
FIGURE 34.4 Higashi-Nada Viaduct collapse in the 1995 Hyogo-Ken Nanbu earthquake. (Source: EERI, The Hyogo-Ren Nambu Earthquake, January 17, 1995, Preliminary Reconnaissance Report, Feb. 1995.)

An excellent example of the effect of construction era is provided by observing the relative performances of bridges on Routes 3 and 5 of the Hanshin Expressway in Kobe. Route 3 was constructed from 1965 through 1970, while Route 5 was completed in the early to mid-1990s [2]. The two routes are parallel to one another, with Route 3 being farther inland and Route 5 being built largely on reclaimed land. Despite the potentially worse soil conditions for Route 5, it performed far better than Route 3, losing only a single span owing apparently to permanent ground deformation and span unseating (Figure 34.3). In contrast, Route 3 has been estimated to have sustained moderate-to-large-scale damage in 637 piers, with damage in over 1300 spans, and approximately 50 spans requiring replacement (see, for example, Figure 34.4).

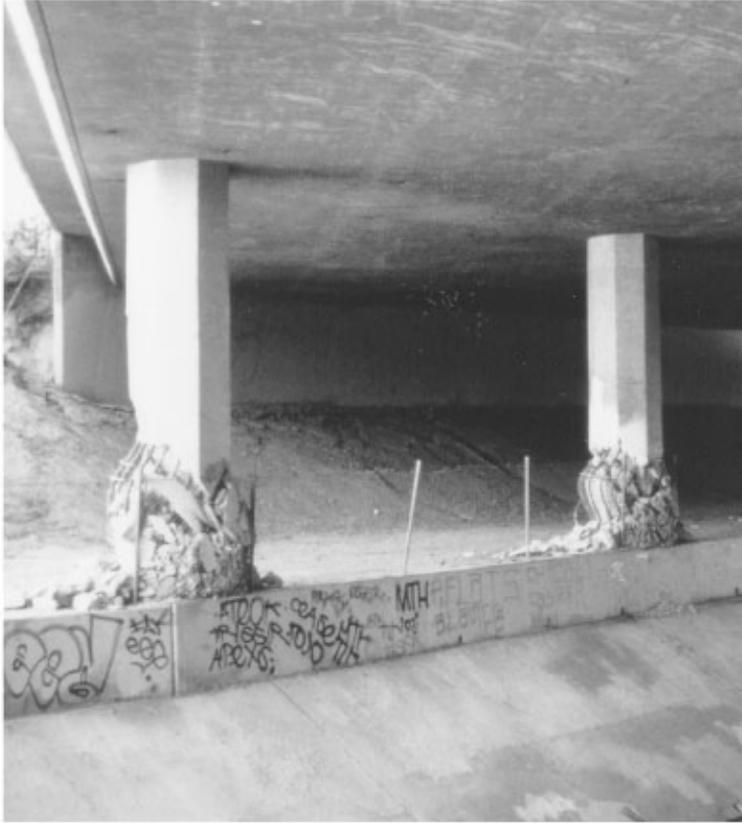
Construction modifications, either during the original construction or during the service life, can also have a major effect on bridge performance. Several graphic examples were provided by the Northridge earthquake [8]. Figure 34.5 shows a bridge column that was unintentionally restrained by a reinforced concrete channel wall. The wall shortened the effective length of the column, increased the column shear force, and shifted nonlinear response from a zone of heavy confinement upward to a zone of light transverse reinforcement, where the ductility capacity was inadequate. Failures of this type illustrate the importance of careful inspection during construction and during the service life of a bridge.

FIGURE 34.5 Bull Creek Canyon Channel Bridge damage in the 1994 Northridge earthquake.

Shear failures in reinforced concrete columns can be induced by interactions with “nonstructural” elements. These elements can decrease the distance between locations of flexural yielding, and therefore increase the shear demand for a column. [Figure 34.5](#), discussed previously, shows a case

in which a channel wall restrained the column at the base and forced the location of yielding to occur higher in the column than was anticipated in design [8]. Figure 34.22 shows a case in which an architectural flare strengthened the upper portion of the column, forcing yielding to occur lower than was intended [8]. In both cases, an element that was not considered in designing the column forced failure to occur in a lightly confined portion of the column that was incapable of resisting the force and deformation demands.

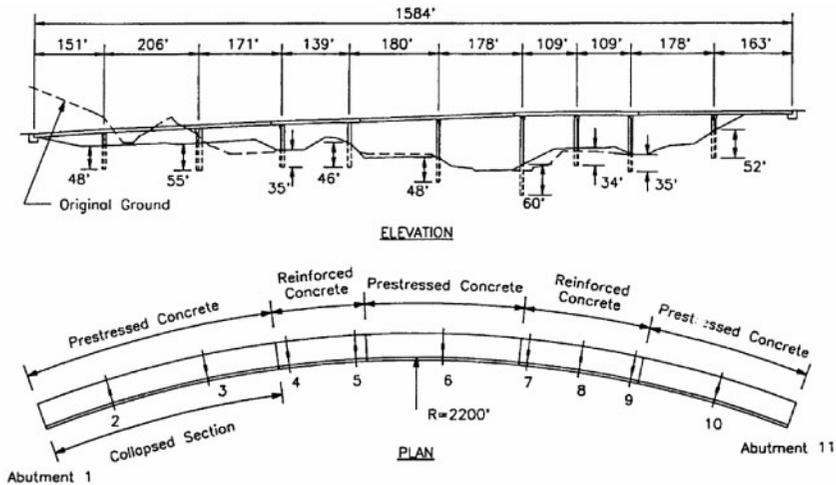
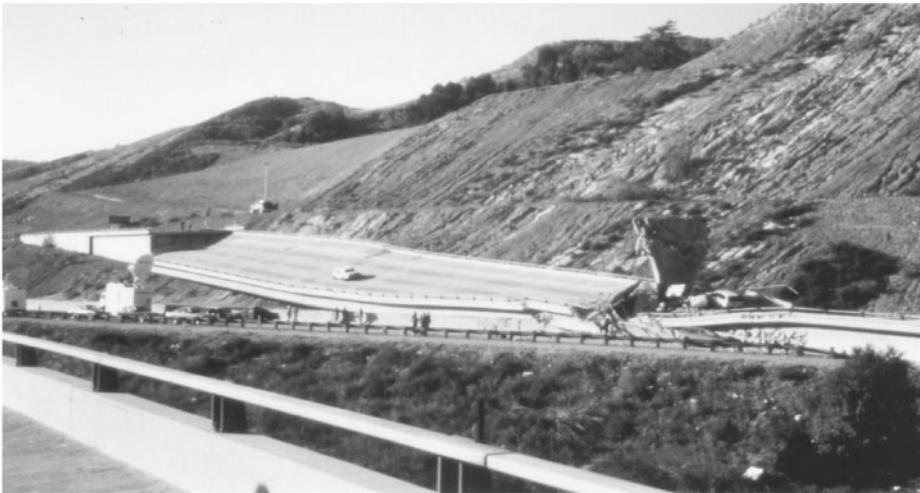
A common form of irregularity arises when a bridge traverses a basin requiring columns of nonuniform length. Although the response of the superstructure may be relatively uniform, the deformation demands on the individual substructure piers are highly irregular; the largest strains are imposed on the shortest columns. In some cases, the deformation demands on the short columns can induce their failure before longer, more flexible adjacent columns can fully participate. The Route 14/5 Separation and Overhead structure provides an example of these phenomena. The structure comprised a box-girder monolithic with single-column bents that varied in height depending on the road and grade elevations (Figure 34.6a). Apparently, the short column at Bent 2 failed in shear because of large deformation demands in that column, resulting in the collapse of the adjacent spans (Figure 34.6b).

FIGURE 34.6 Geometry and collapse of the Route 14/5 Separation and Overhead in the 1994 Northridge earthquake. (a) Configuration [8]; (b) photograph of collapse.

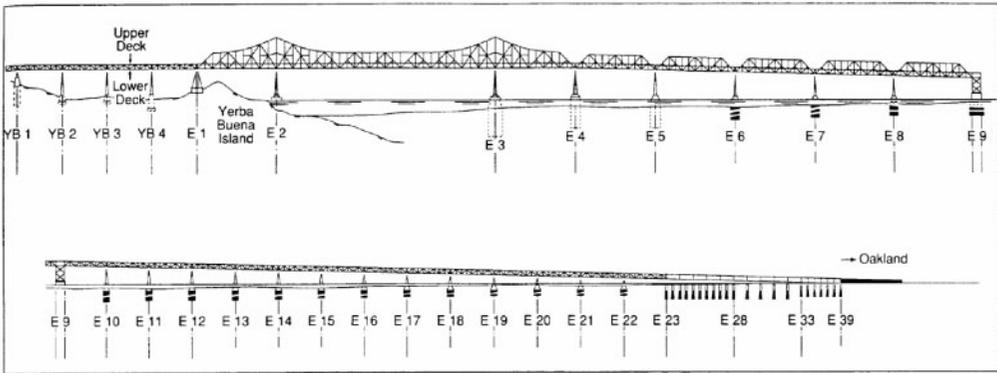
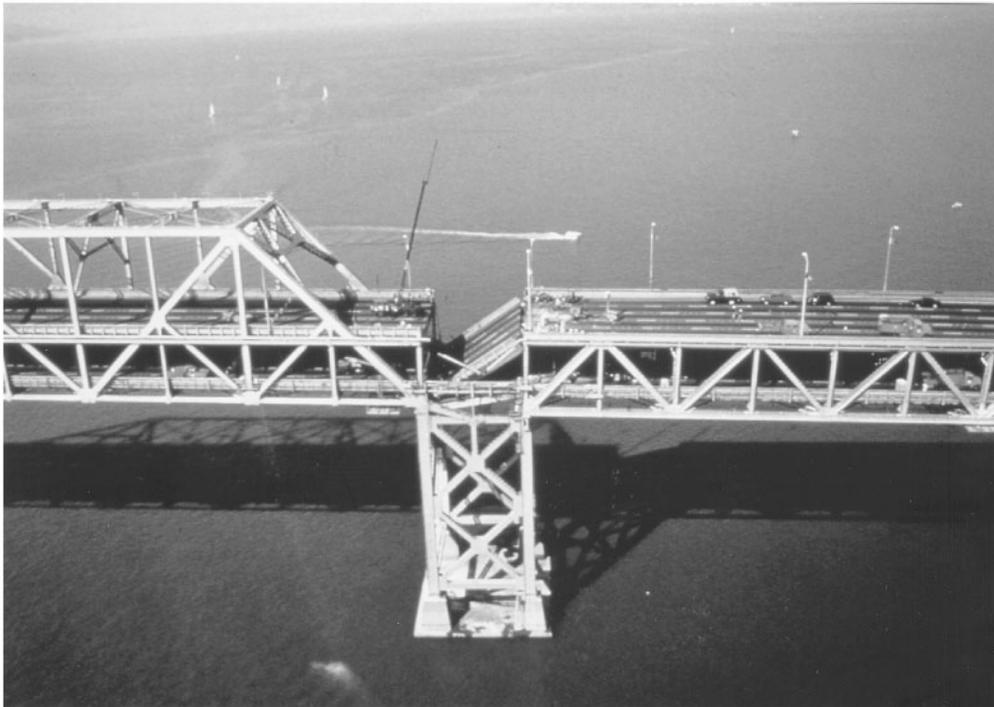
The effects identified above can be exacerbated in long-span bridges. In addition to changes in subgrade and structural irregularities that may be required to resolve complex foundation and transportation requirements, long bridges can be affected by spatial and temporal variations in the ground motions. Expressed in simple terms, different piers are subjected to different ground motions at any one time, because seismic waves take time to travel from one bridge pier to another. This effect can result in one pier being pulled in one direction while the other is being pushed in the opposite direction. This complex behavior is not accounted for directly in conventional bridge design. An example where this behavior may have resulted in increased damage and collapse is the eastern portion of the San Francisco–Oakland Bay Bridge ([Figure 34.7a](#)). This bridge includes a variety of different superstructure and substructure configurations, traverses variable subsoils, and is long enough for spatial and temporal variations in ground motions to induce large relative displacements between adjacent bridge segments. The bridge lost two spans, one upper and one lower, at a location where the superstructure was required to accommodate differential movements of adjacent bridge segments ([Figure 34.7b](#)).

FIGURE 34.7 San Francisco–Oakland Bay Bridge, east crossing; geometry and collapse in the 1989 Loma Prieta earthquake. (a) Configuration [10]; (b) photograph of collapse.

A spectacular example of steel superstructure failure and collapse is that of the eastern portion of the San Francisco–Oakland Bay Bridge during the 1989 Loma Prieta earthquake (see [Figure 34.7](#)) [10]. In this bridge, a 50-ft (15-m) span over tower E9 was a transition point between 506-ft (154-m) truss spans to the west and 290-ft (88-m) truss spans to the east, serving to transmit longitudinal forces among the adjacent spans and the massive steel tower at E9. Failure of a bolted connection between the 290-ft (88-m) span truss and the tower resulted in sliding of the span and unseating of the transition span over tower E9. This collapse resulted in closure for 1 month of this critical link between San Francisco and the East Bay.

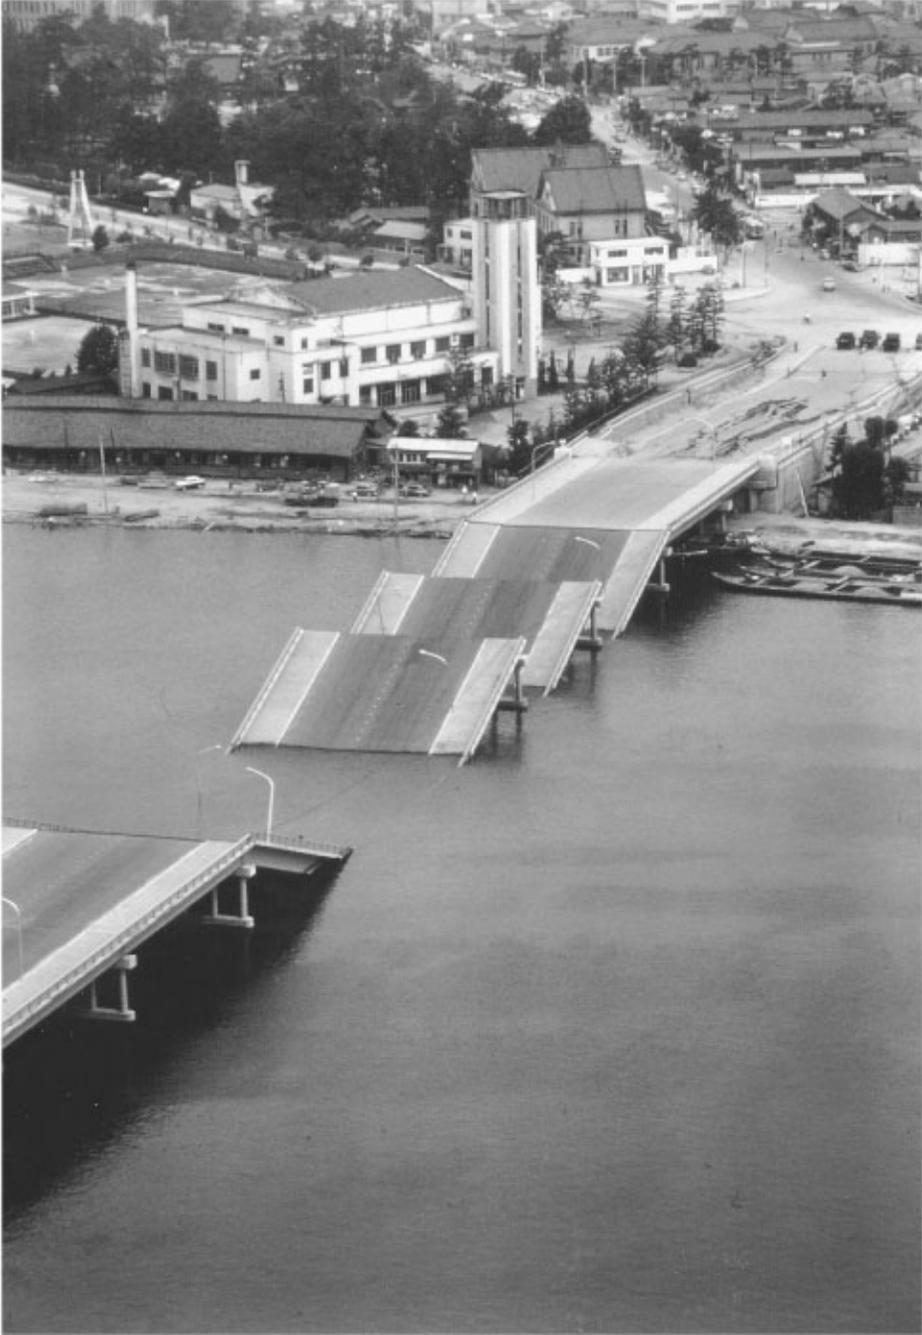
deformation. Unseating of simple spans was observed in California in earlier earthquakes, leading in recent decades to development of bridge construction practices based on monolithic box-girder-substructure construction. Problems of unseating still occur with older bridge construction and with new bridges in regions where simple spans are still common. For example, during the 1991 Costa Rica earthquake, widespread liquefaction led to abutment and internal bent rotations, resulting in the collapse of no fewer than four bridges with simple supports [7]. The collapse of the Showa Bridge in the 1964 Niigata earthquake demonstrates one result of the unseating of simple spans (Figure 34.8).

FIGURE 34.8 Showa Bridge collapse in 1964 Niigata earthquake.

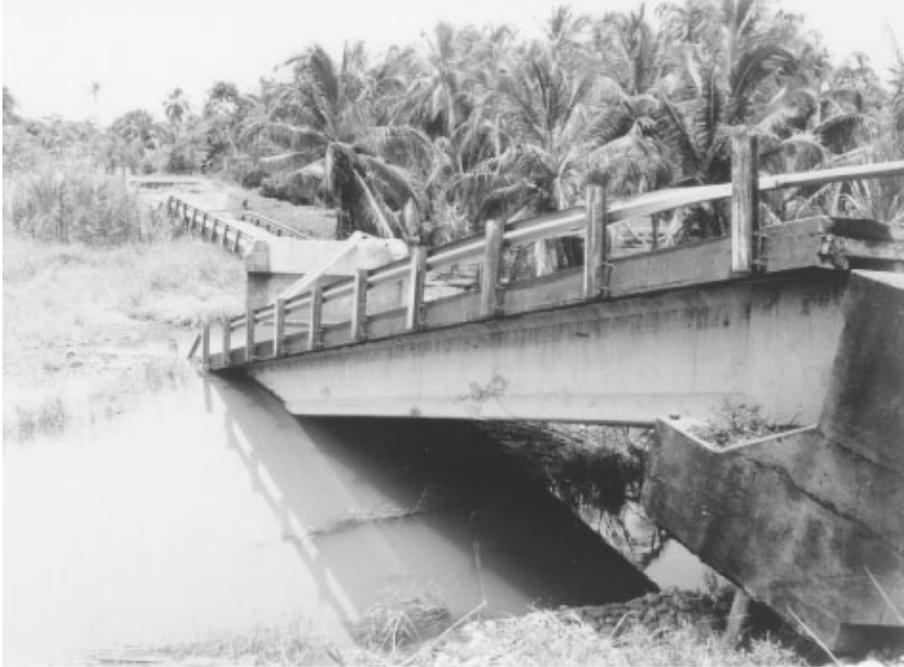
FIGURE 34.9 Rio Bananito Bridge collapse in the 1991 Costa Rica earthquake. (Source: EERI, *Earthquake Spectra*, Special Suppl. to Vol. 7, 1991.)

Several examples of skewed bridge damage and collapse can be found in the literature [7,8,12]. A typical example is the Rio Bananito Bridge, in which the bridge and central slab pier were skewed at 30° , which lost both spans off the central pier in the direction of the skew during the 1991 Costa Rica earthquake (Figure 34.9) [7]. Another example of skewed bridge failure is the Gavin Canyon Undercrossing, which failed during the 1994 Northridge earthquake [8]. Both skewed hinges became unseated during the earthquake, resulting in collapse of the unseated spans (Figure 34.10).

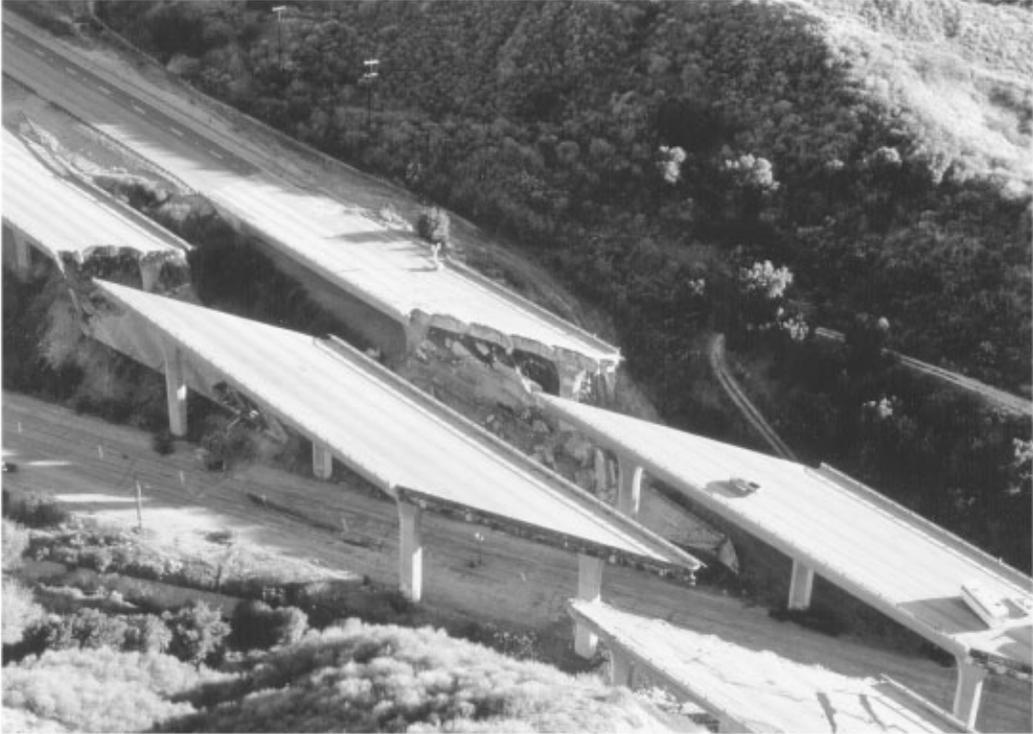
Hinge restrainers appear to have been effective in preventing unseating in both the Loma Prieta [10] and Northridge earthquakes [8]. In some other cases, hinge restrainers were not fully effective in preventing unseating. For example, the hinge restrainers in the Gavin Canyon Undercrossing, which were aligned parallel the bridge alignment, did not prevent unseating (see Figure 34.10).

FIGURE 34.10 Gavin Canyon Undercrossing collapse in the 1994 Northridge earthquake.

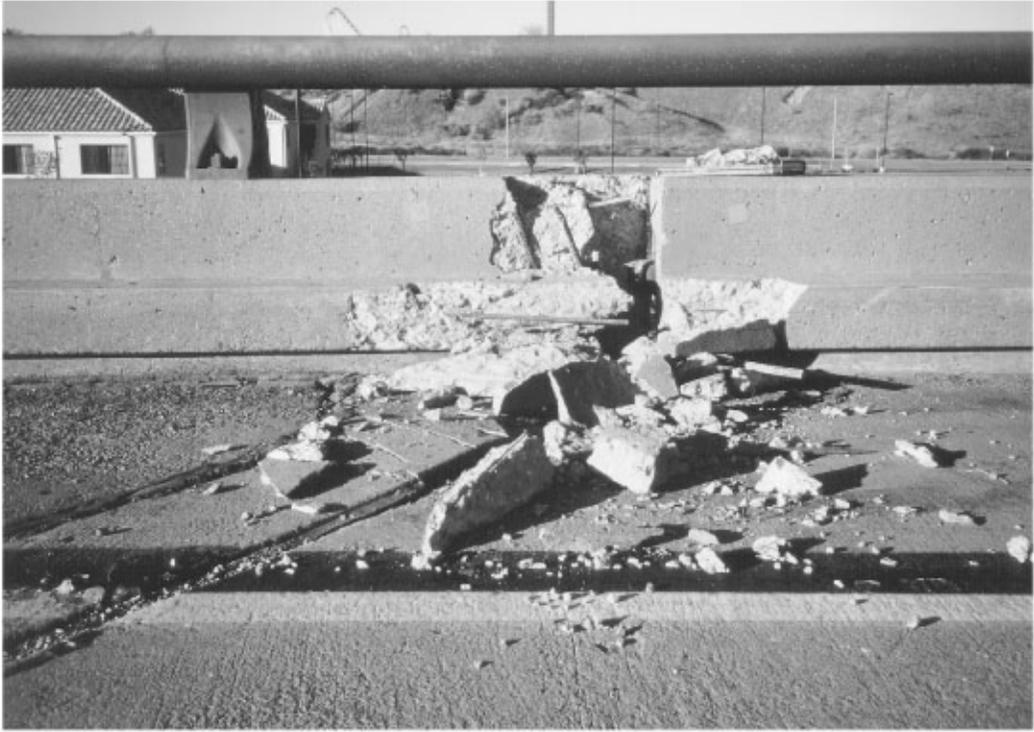
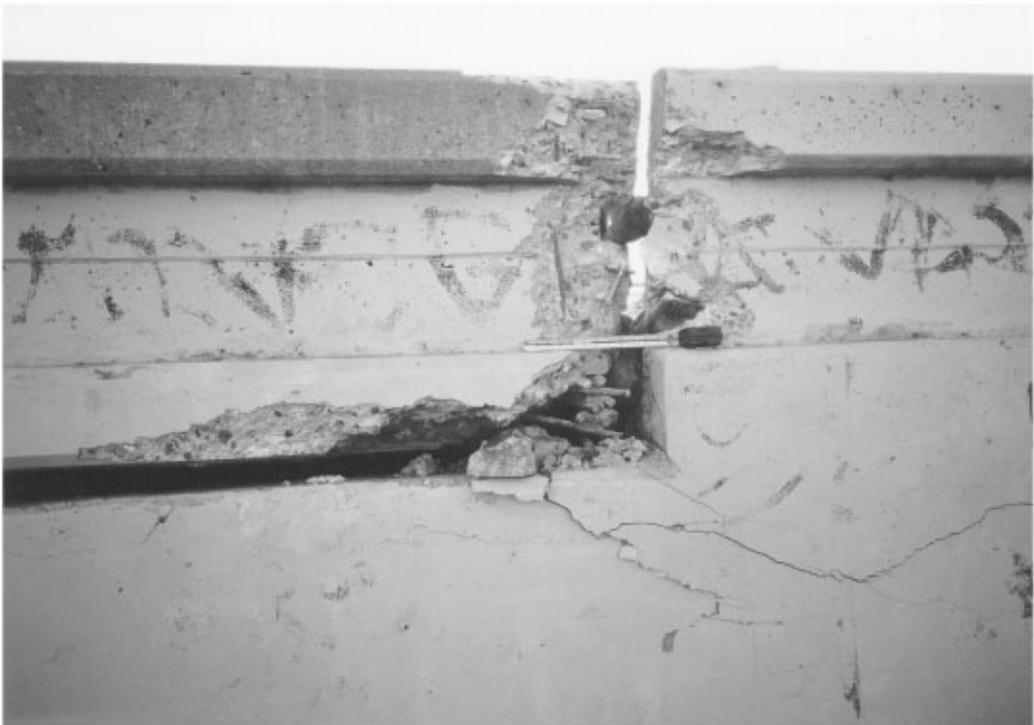
With the exception of bridge superstructures that come unseated and collapse, the most common form of damage to superstructures is due to pounding of adjacent segments at the expansion hinges. This type of damage occurs in bridges of all construction materials. [Figure 34.11a](#) shows pounding damage at an in-span expansion joint of the Santa Clara River Bridge during the 1994 Northridge earthquake, and [Figure 34.11b](#) shows pounding damage at an abutment of the same structure.

FIGURE 34.11 Santa Clara River Bridge pounding damage in 1994 Northridge earthquake. (a) Barrier rail pounding damage; (b) abutment pounding damage.

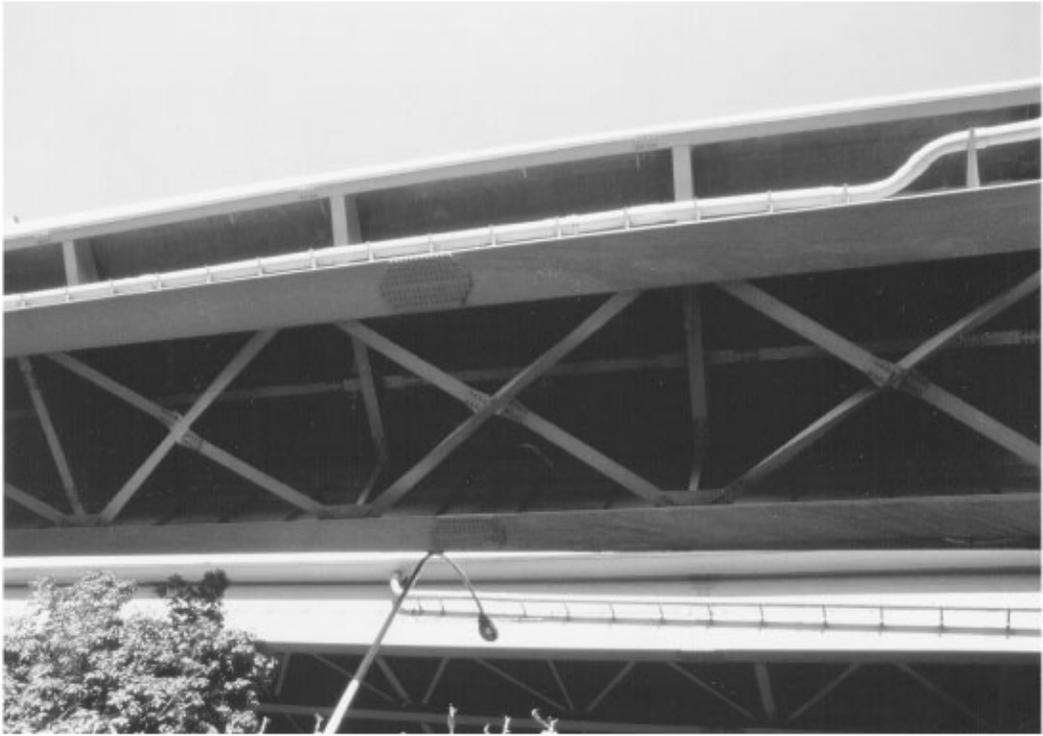
FIGURE 34.12 Buckling of braces near pier 209 of the Hanshin Expressway in the 1995 Hyogo-Ken Nanbu earthquake.

Steel superstructures commonly comprise lighter framing elements, especially for transverse bracing. These have been found to be susceptible to damage due to transverse loading, especially following failure of bearings [1,8]. Several cases of steel superstructure damage occurred in the Hyogo-Ken Nanbu earthquake. [Figure 34.12](#) shows buckling of cross braces beneath the roadway of a typical steel girder bridge span of the Hanshin Expressway. [Figure 34.13](#) shows girder damage in the same expressway due to excessive lateral movement at the support. [Figure 34.14](#) shows buckled cross-members between the upper chords of the Rokko Island Bridge. That single-span, 710-ft (217-m) tied-arch span bridge slipped from its expansion bearings, allowing the bridge to move laterally about 10 ft (3 m). The movement was sufficient for one end of one arch to drop off the cap beam, twisting the superstructure and apparently resulting in the buckling of the top chord bracing members [2,3].

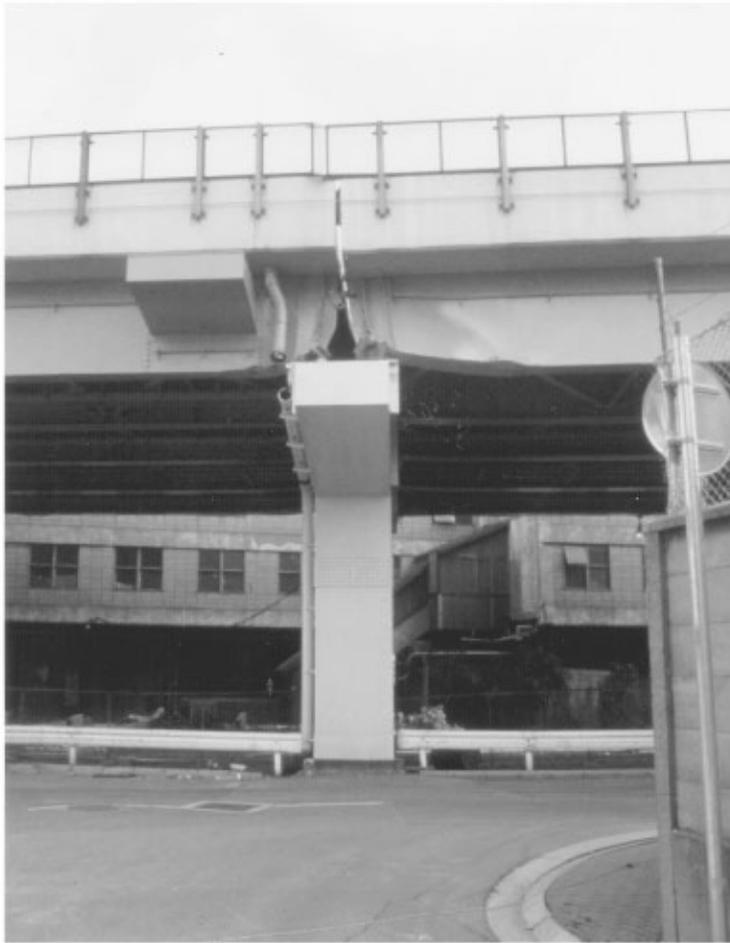
FIGURE 34.13 Girder damage at Bent 351 of the Hanshin Expressway apparently due to transverse movement during the 1995 Hyogo-Ken Nanbu earthquake.

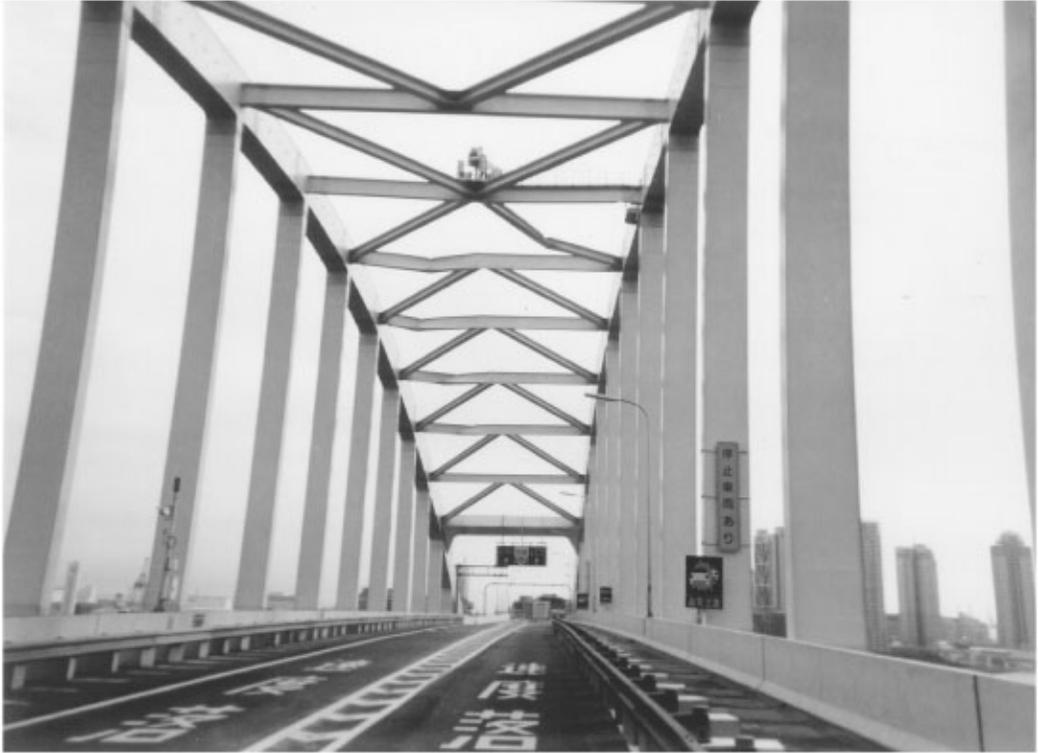
FIGURE 34.14 Buckling of cross-members in the upper chord of the Rokko Island Bridge in the 1995 Hyogo-Ken Nanbu earthquake.

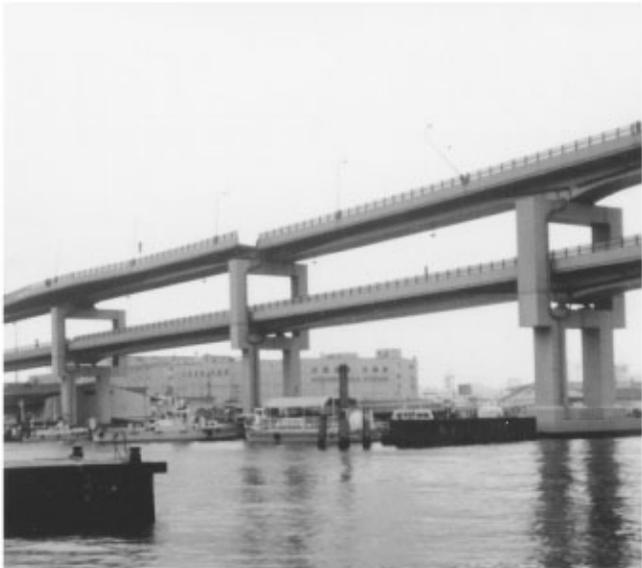
FIGURE 34.15 Hamate Bypass superstructure rotations as a result of bearing failures in the 1995 Hyogo-Ken Nanbu earthquake.

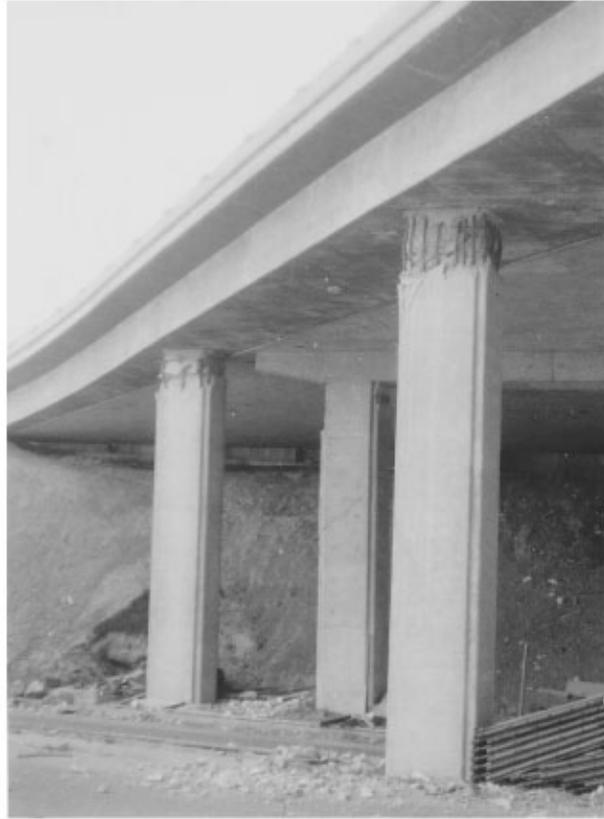
FIGURE 34.17 San Fernando Road Overhead damage in the 1971 San Fernando earthquake.

core of these columns. This amount and type of reinforcement provides negligible confinement to the concrete, particularly in large columns. [Figure 34.17](#) shows bridge columns that had insufficient flexural ductility to withstand the 1971 San Fernando earthquake. [Figure 34.18](#) shows similar damage in a circular cross section column in the 1995 Hyogo-Ken Nanbu earthquake.

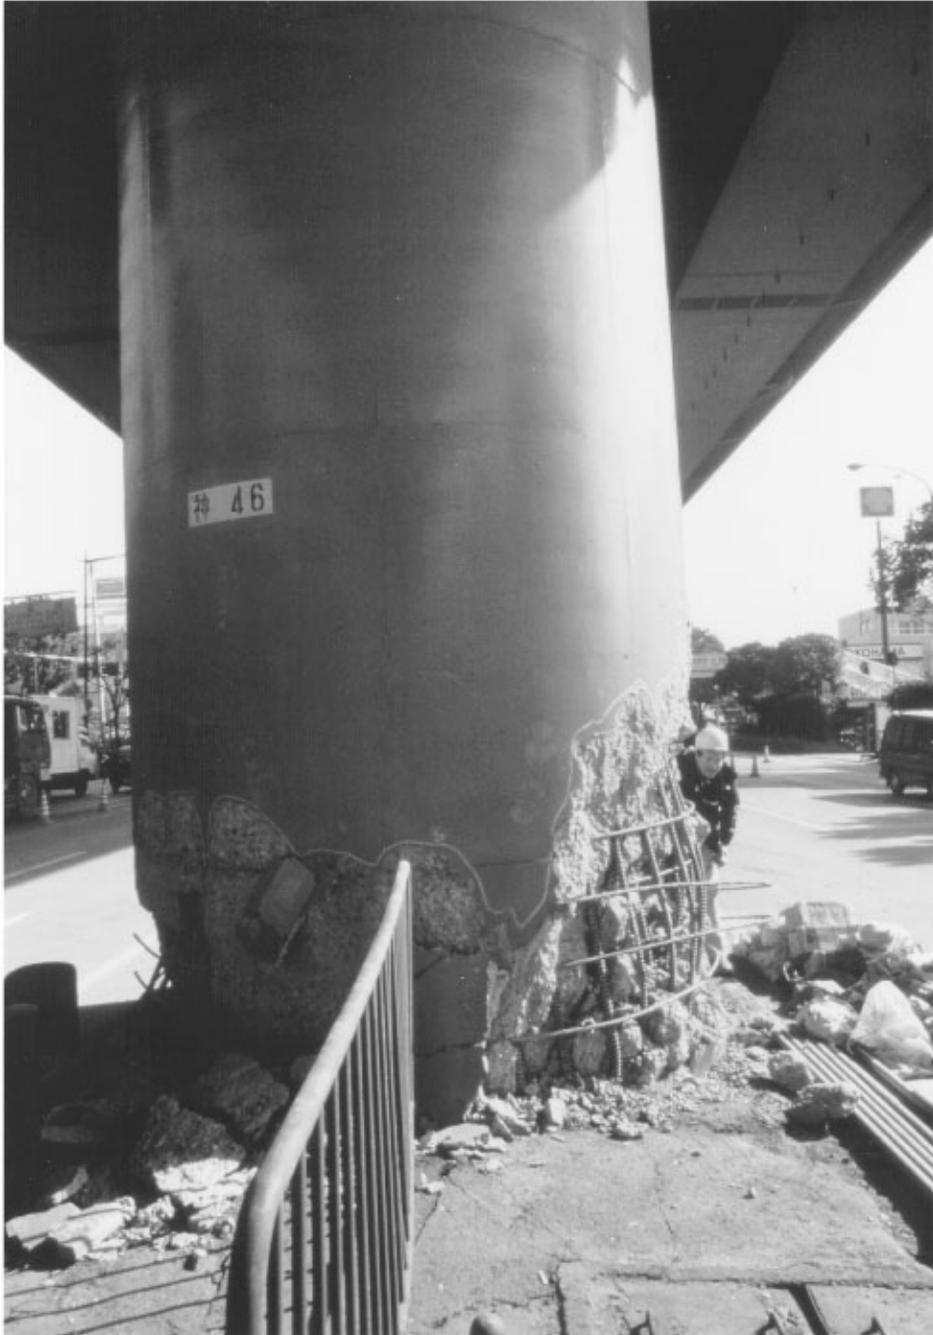
FIGURE 34.18 Hanshin Expressway, Pier 46, damage in the 1995 Hyogo-Ken Nanbu earthquake.

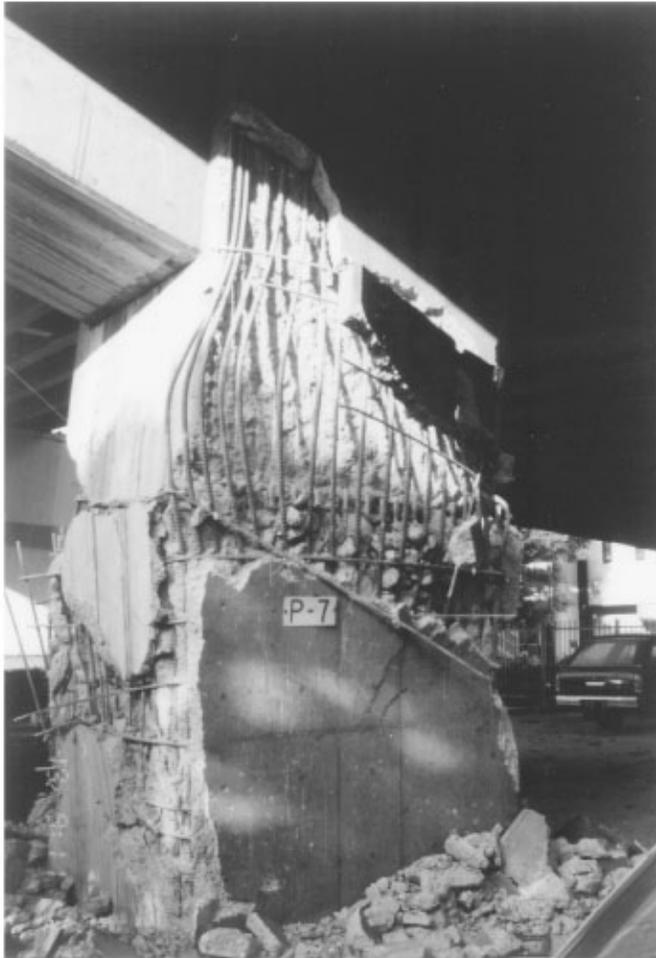
Other detailing practices (in addition to providing little confinement) may lead to flexural failure in reinforced concrete columns. A common practice in Japan has been to terminate some of the longitudinal reinforcement within the column height. The resulting development length of the terminated reinforcement can be inadequate, and may lead to splitting failure along the terminated bars or to flexural and shear distress near the cutoff point. [Figure 34.19](#) illustrates failure of a column with bars terminated near the column midheight. In the case of the Hanshin Expressway Route 3, which collapsed during the 1995 Hyogo-Ken Nanbu earthquake (see [Figure 34.4](#)), the curtailment of one third of the main reinforcement was accompanied by the use of gas-pressure butt welding of the continuing longitudinal reinforcement. In tests following the earthquake, approximately half of the undamaged, butt-welded bars failed at the welds [\[14\]](#).

FIGURE 34.19 Failure of column with longitudinal reinforcement cutoffs near midheight in the 1995 Hyogo-Ken Nanbu earthquake.

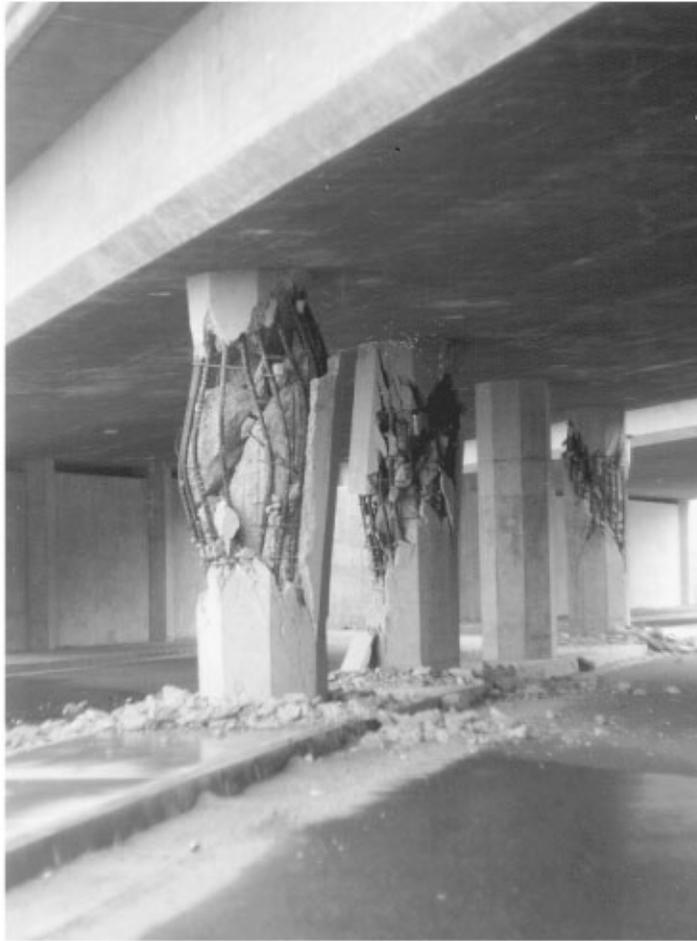
FIGURE 34.20 Failure of columns of the Route 5/210 interchange during the 1971 San Fernando earthquake.

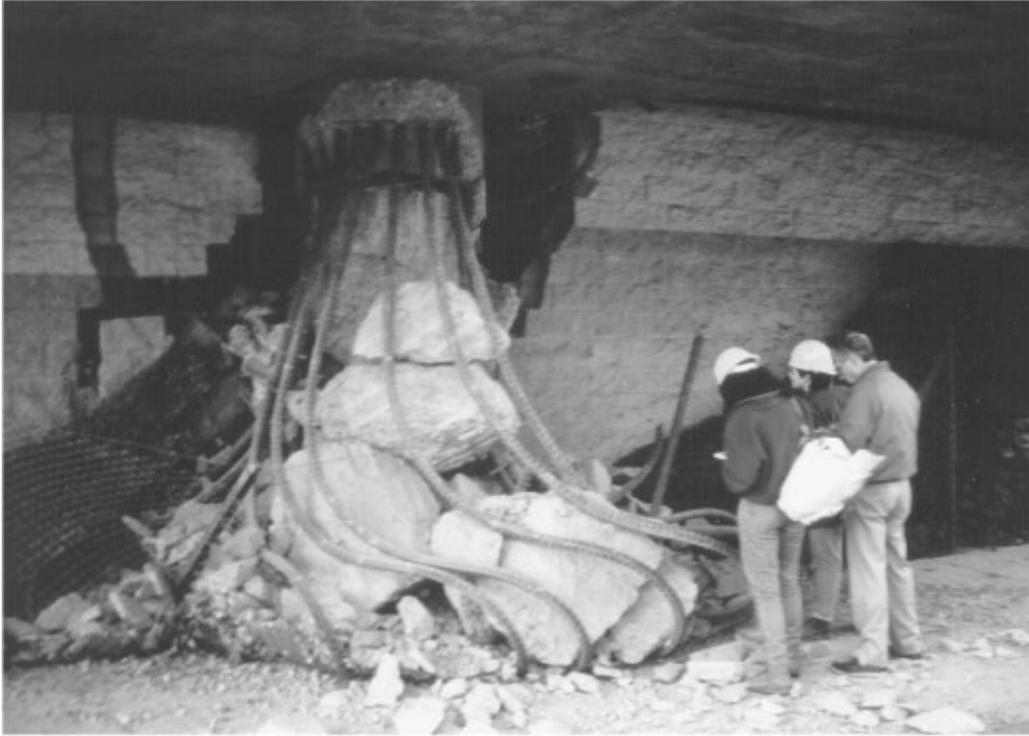
cycles combined with vertical loads, a column can degrade to nearly complete loss of load-carrying capacity, as suggested by the heavily damaged column in [Figure 34.21](#). Provision of closely spaced transverse reinforcement as required in some modern codes is required to prevent this type of failure.

FIGURE 34.21 Failure of columns of Interstate 10, La Cienega-Venice Undercrossing in the 1994 Northridge earthquake. (Masonry walls of storage units are supporting the collapsed frame.)

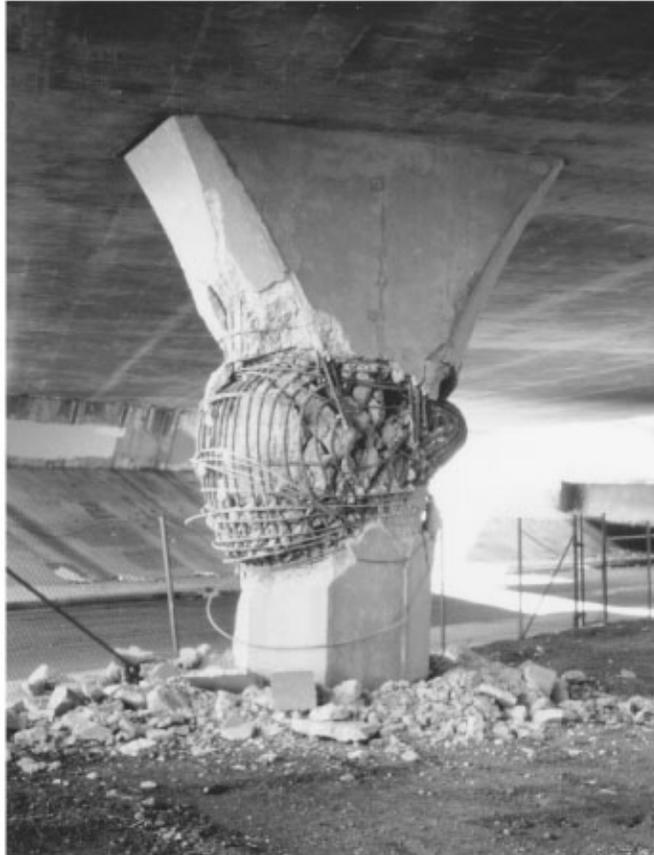
FIGURE 34.22 Failure of flared column in the Route 118, Mission-Gothic Undercrossing, in the 1994 Northridge earthquake.

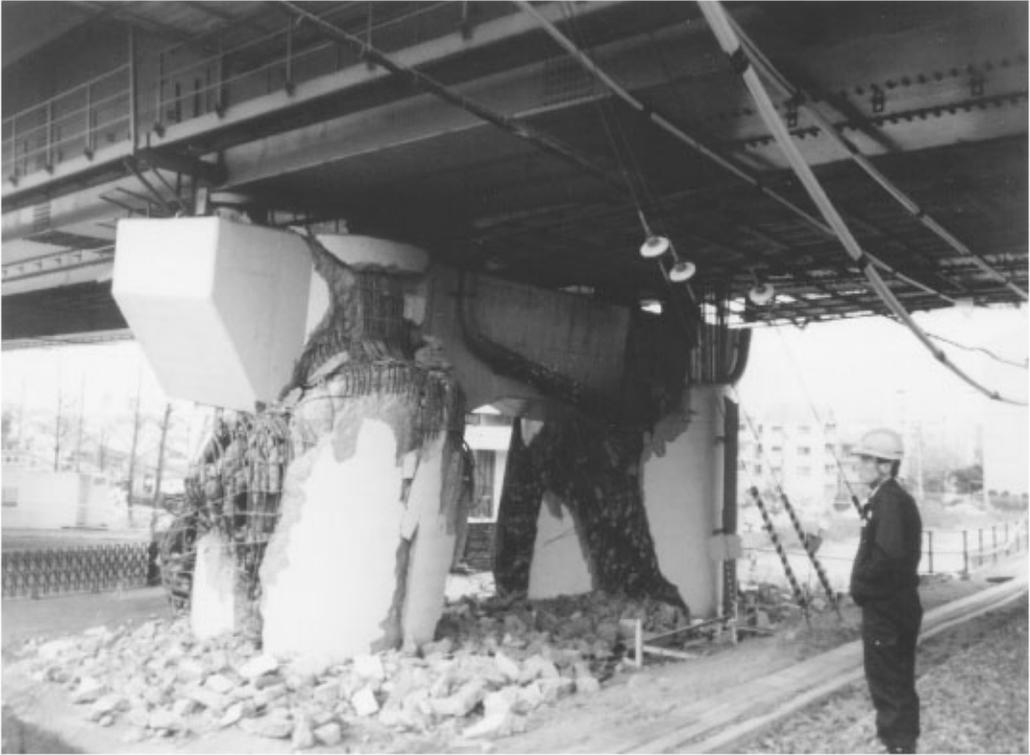
Figure 34.23 illustrates the failure of a stout, two-column bent on a spur just to the north of the Hanshin Expressway in the 1995 Hyogo-Ken Nanbu earthquake. The failure involves shattering of the columns, bent cap, and joints, and shatters the notion that strength alone is an adequate provision for bridge seismic design.

FIGURE 34.23 Failure of a two-column bent in the 1995 Hyogo-Ken Nanbu earthquake.

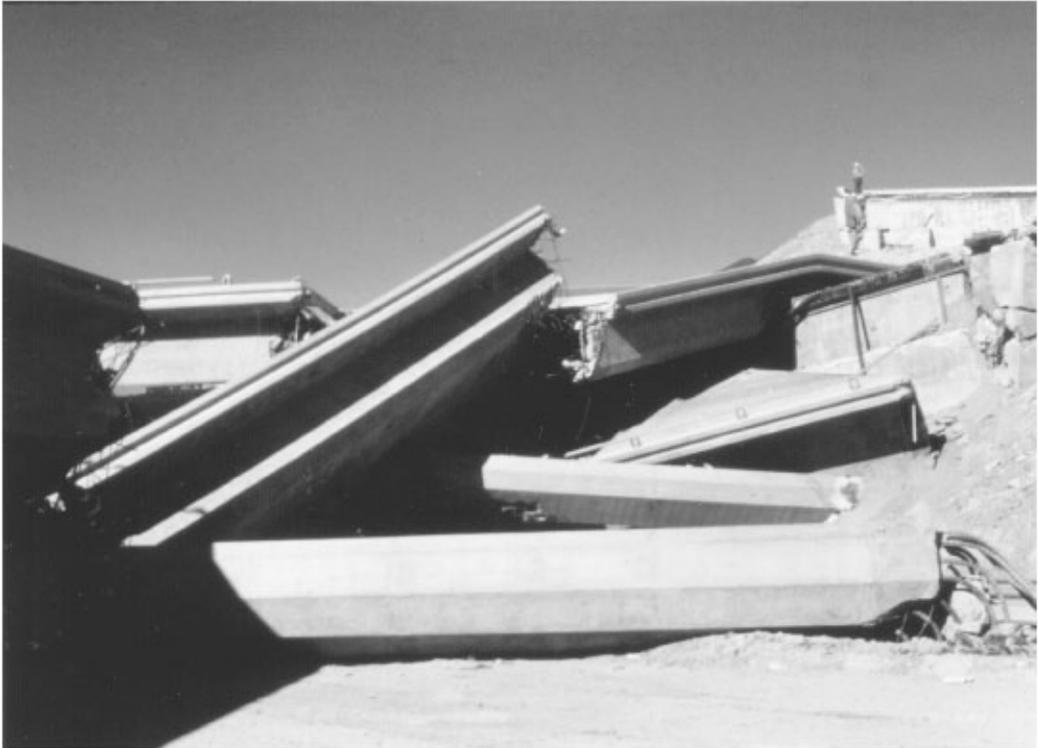
FIGURE 34.24 Failure at the base of a column supported on a single cast-in-place pile in the 1971 San Fernando earthquake [Steinbrugge Collection, EERC Library, University of California, Berkeley].

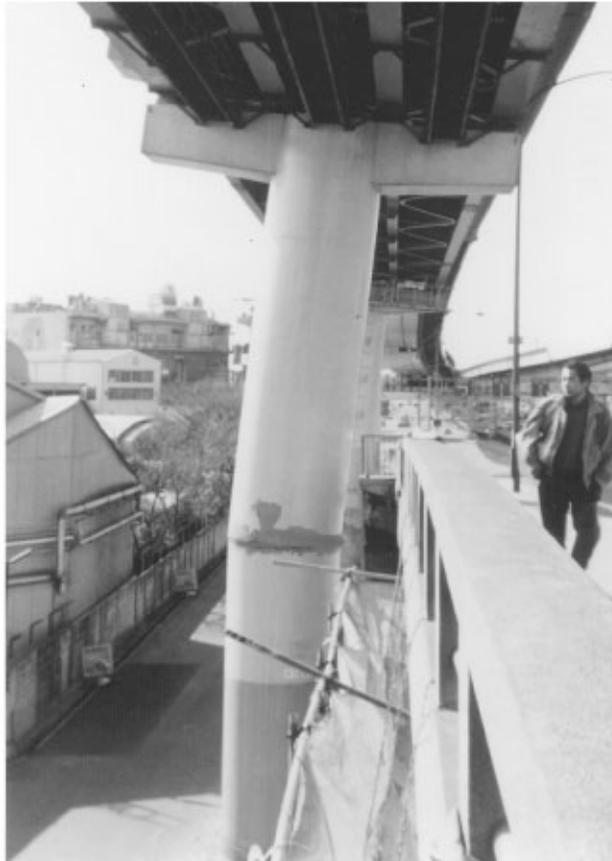
FIGURE 34.25 Local buckling of a circular cross-section column of the Hanshin Expressway in the 1995 Hyogo-Ken Nanbu earthquake.

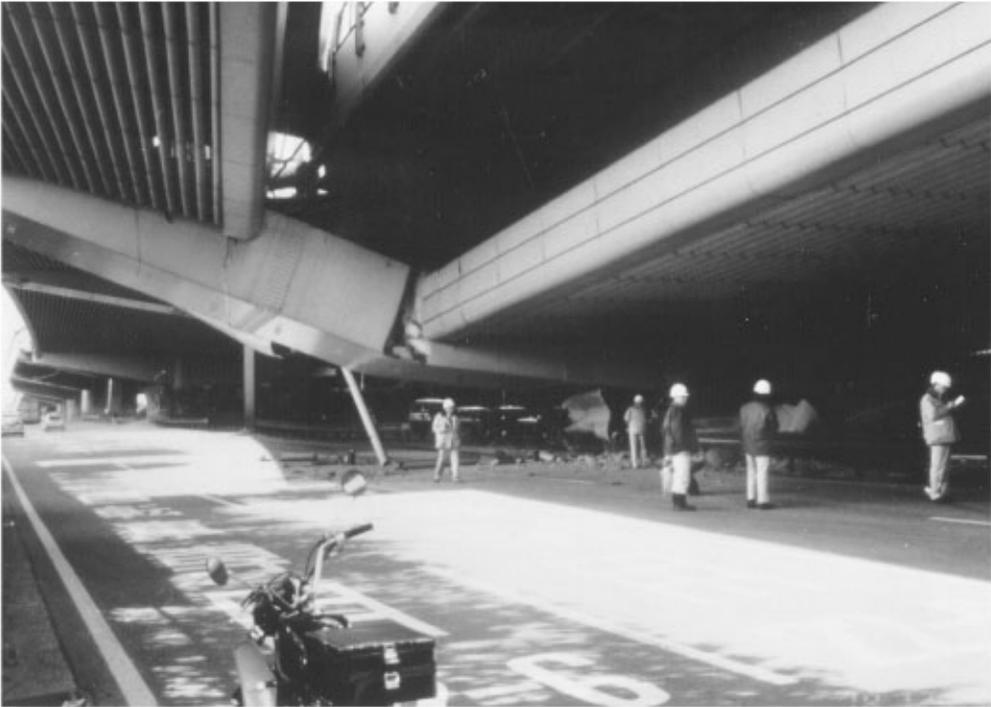
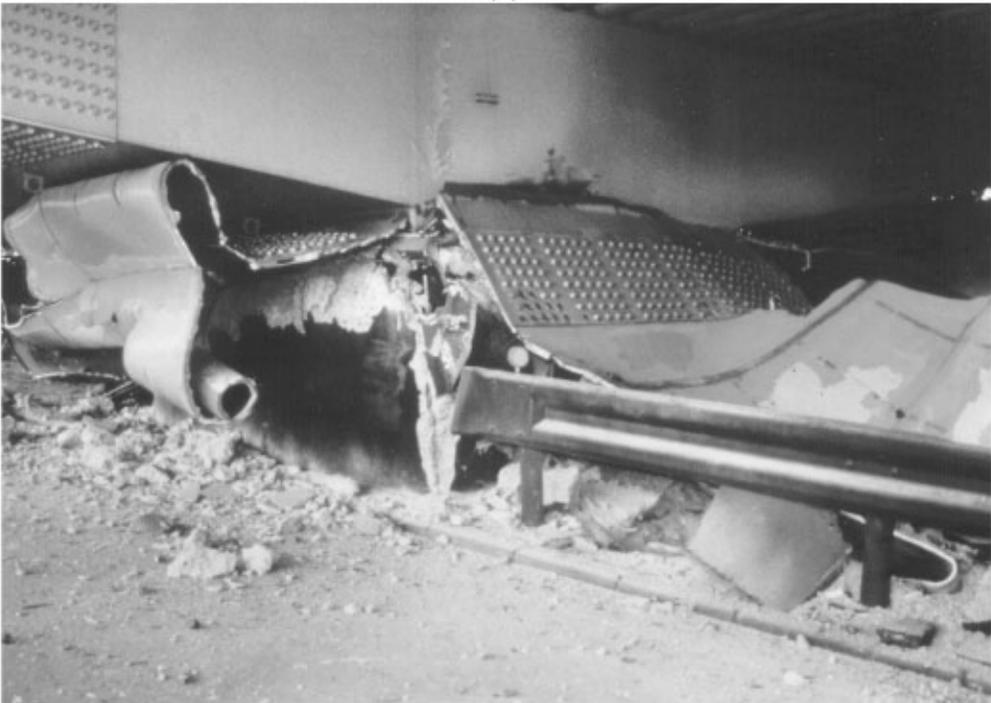
The record of steel column failures is sparse, because few bridges with steel columns have been subjected to strong earthquakes elsewhere than Japan. In the 1995 Hyogo-Ken Nanbu earthquake, failures apparently were associated with local buckling and subsequent splitting at welds or tearing of steel near the buckle. In columns with circular cross sections, the local buckling sometimes occurred at locations where section thicknesses changed. [Figure 34.25](#) illustrates the formation of a local buckle in a circular cross section column accompanied by visible plastic deformation. In rectangular columns, local buckling of web and flange plates was insufficiently restrained by small web stiffeners [14]. [Figure 34.26](#) illustrates the collapse of a rectangular column. A nearby column sustained local buckling at the base and tearing of the vertical welded seam between the two steel plates forming a corner of the column, suggesting the nature of failure that resulted in the collapse shown in [Figure 34.26](#).

FIGURE 34.26 Collapse of a rectangular cross section steel column in the 1995 Hyogo-Ken Nanbu earthquake. (a) Collapsed bent and superstructure; (b) close-up of collapsed column.
