Moehle, J.P., Eberhard, M.O. "Earthquake Damage to Bridges."
Bridge Engineering Handbook.
Ed. Wai-Fah Chen and Lian Duan
Boca Raton: CRC Press, 2000

Earthquake Damage to Bridges

Jack P. Moehle

Marc O. Eberhard

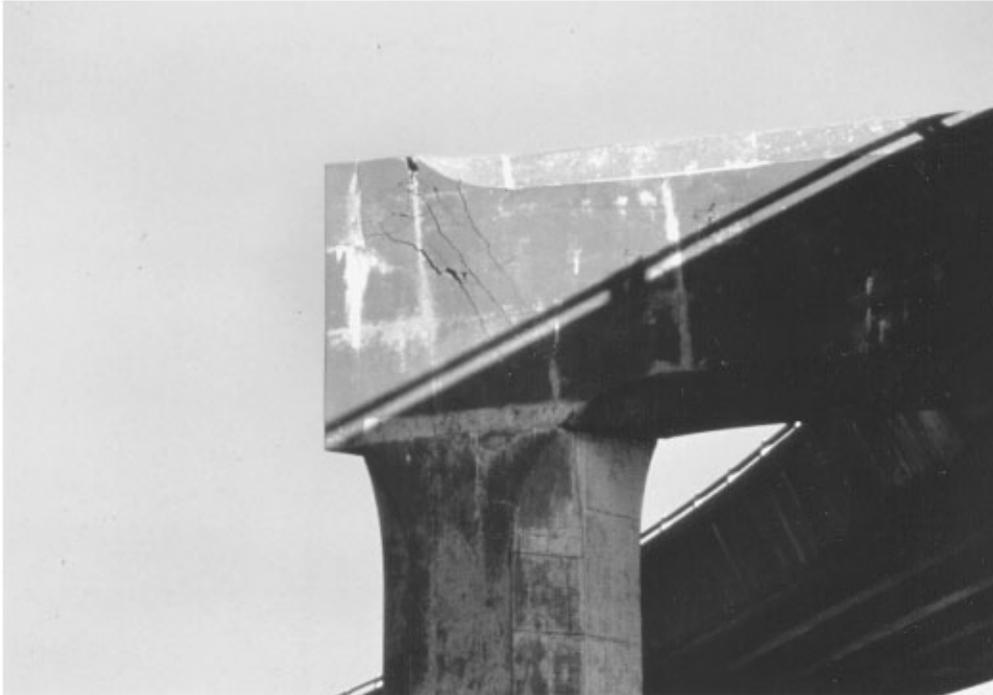
FIGURE 34.27 Outrigger damage in the 1989 Loma Prieta earthquake.

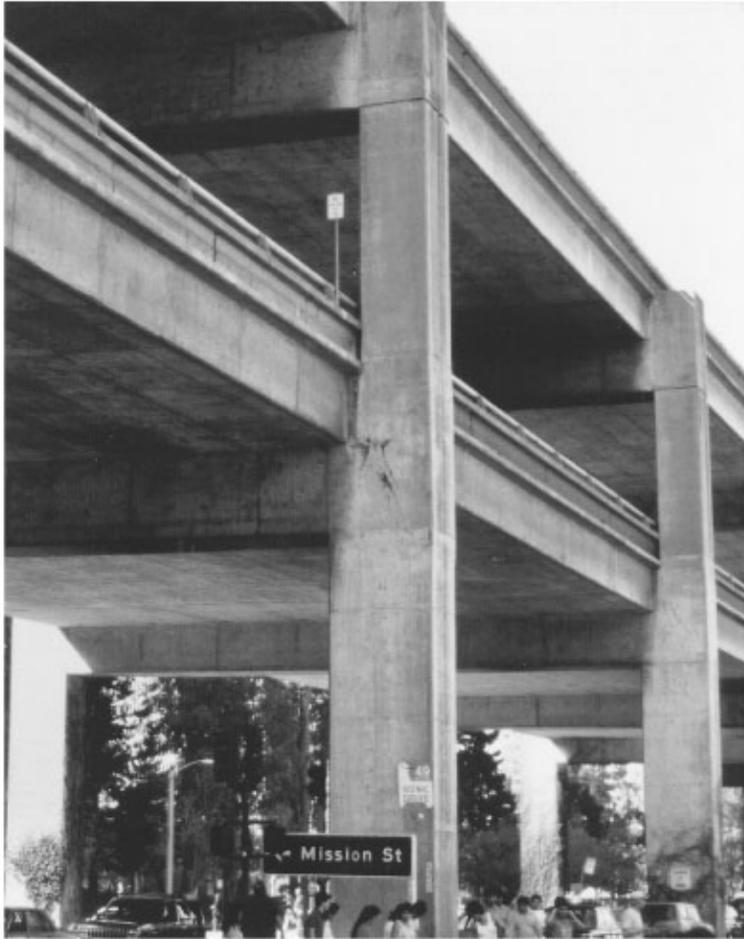
FIGURE 34.28 Embarcadero Viaduct damage during the 1989 Loma Prieta earthquake.

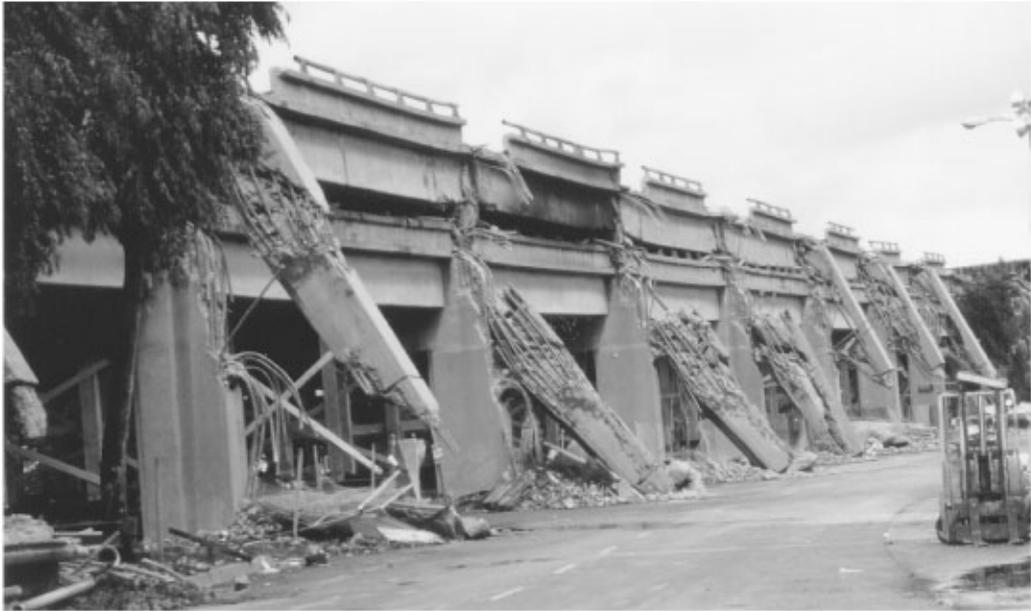
The collapse of the Cypress Street Viaduct during the Loma Prieta earthquake had more severe consequences ([Figure 34.29](#)). Failure of a concrete pedestal located just above the first-level joint

led to the collapse of the upper deck on the lower deck, at a cost of 42 lives. Such pedestals are not common, but this collapse demonstrates that each earthquake has the potential to reveal a mode of failure that has not yet been considered routinely.

FIGURE 34.29 Cypress Street Viaduct collapse in the 1989 Loma Prieta earthquake.

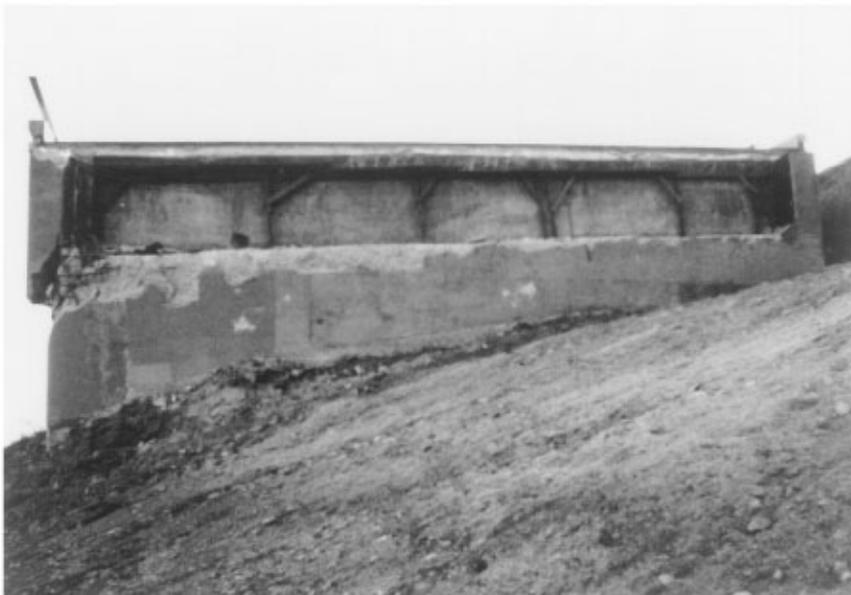
FIGURE 34.30 Damage to external shear key in an abutment in the 1994 Northridge earthquake. (Source: EERI, *Earthquake Spectra*, Special Suppl. to Vol. II, 1995.)

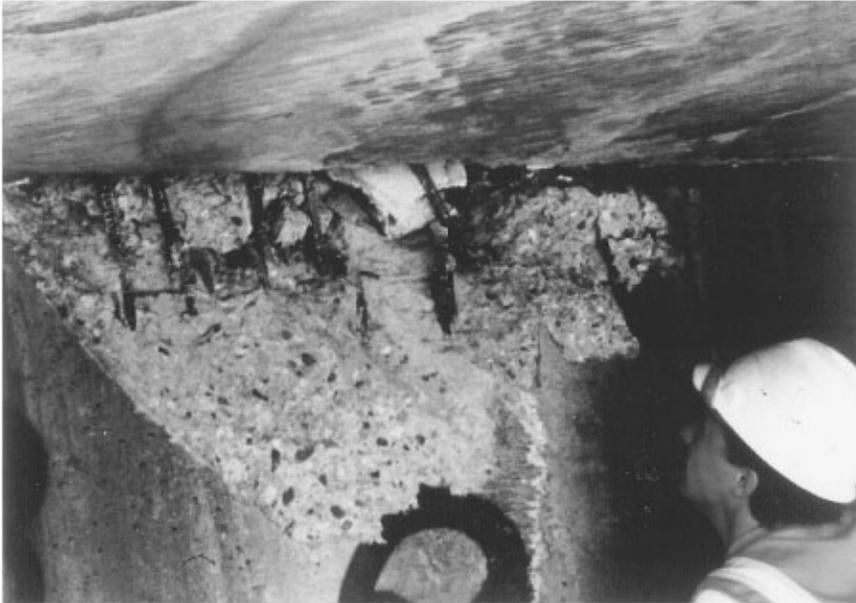
FIGURE 34.31 Damage to internal shear key in an abutment in the 1994 Northridge earthquake. (Source: EERI, *Earthquake Spectra*, Special Suppl. to Vol. II, 1995.)

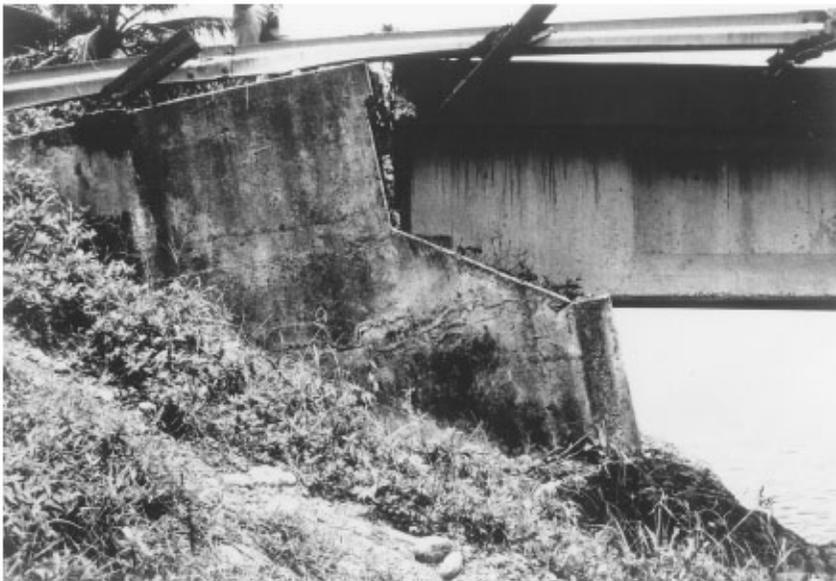
Foundation damage associated with liquefaction-induced lateral spreading has probably been the single greatest cause of extreme distress and collapse of bridges [12]. The problem is especially critical for bridges with simple spans (see Figure 34.8). The 1991 Costa Rica earthquake provides many examples of foundation damage [7]. For example, Figure 34.32 shows an abutment that

FIGURE 34.32 Rotation of abutment due to liquefaction and lateral spreading during the 1991 Costa Rica earthquake. (Source: EERI, *Earthquake Spectra*, Special Suppl. to Vol. 7, 1991.)

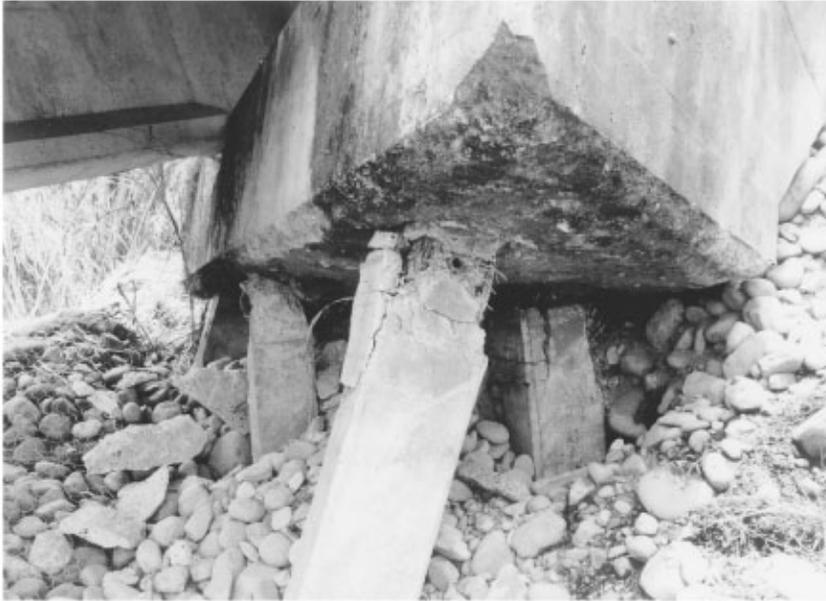
FIGURE 34.33 Abutment piles damaged during the 1991 Costa Rica earthquake. (Source: EERI, *Earthquake Spectra*, Special Suppl. to Vol. 7, 1991.)

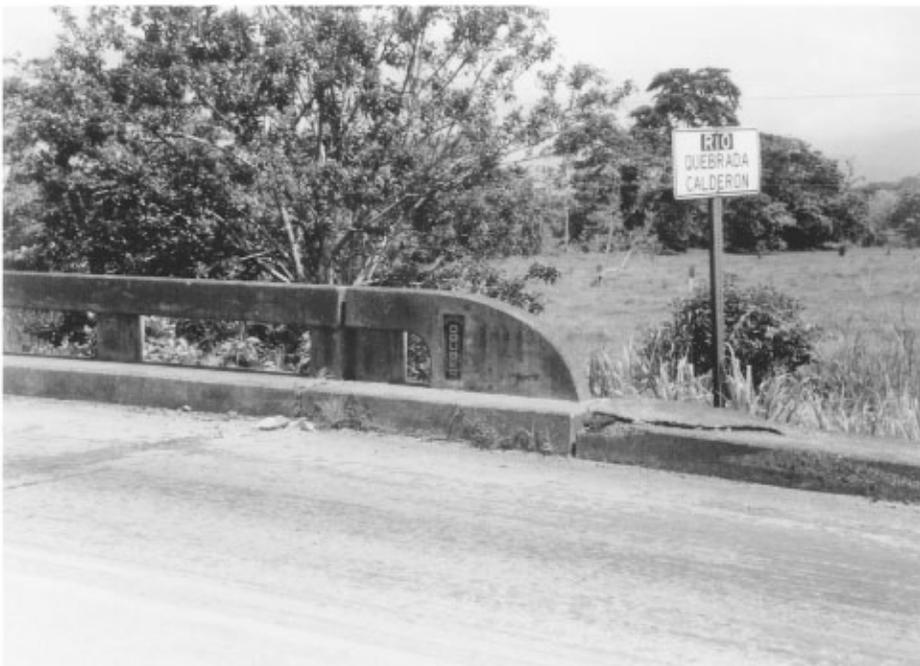
FIGURE 34.34 Settlement slab spanning across slumped abutment fill material at the Rio Quebrada Calderon bridge in the 1991 Costa Rica earthquake. (Source: EERI, *Earthquake Spectra*, Special Suppl. to Vol. 7, 1991.)
