Yashinsky, M. "Earthquake Damage to Structures"  
*Structural Engineering Handbook*.  
Ed. Lian Duan  
Boca Raton: CRC Press LLC, 2001

# Earthquake Damage to Structures

Mark Yashinsky  
*Caltrans Office of  
Earthquake Engineering*

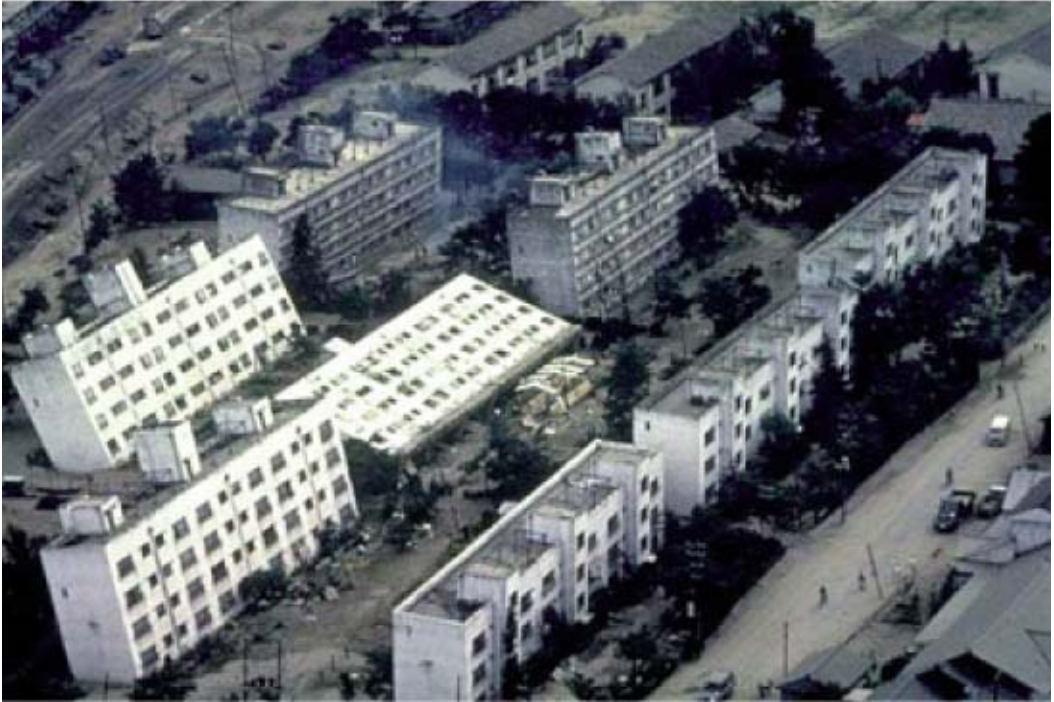
**FIGURE 30.4** Liquefaction-caused building failure in Niigata, Japan. (Photograph by Joseph Penzien and courtesy of Steinbrugge Collection, Earthquake Engineering Research Center, University of California, Berkeley.)

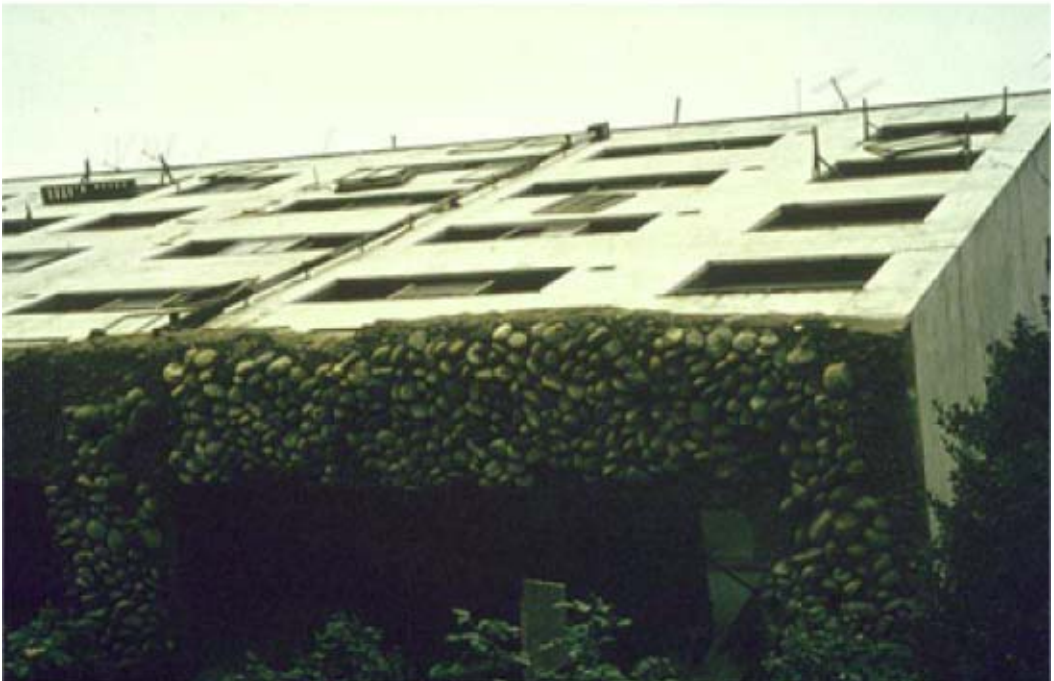
**FIGURE 30.5** Liquefaction-caused building failure in Niigata, Japan. (Photograph by Joseph Penzien and courtesy of Steinbrugge Collection, Earthquake Engineering Research Center, University of California, Berkeley.)

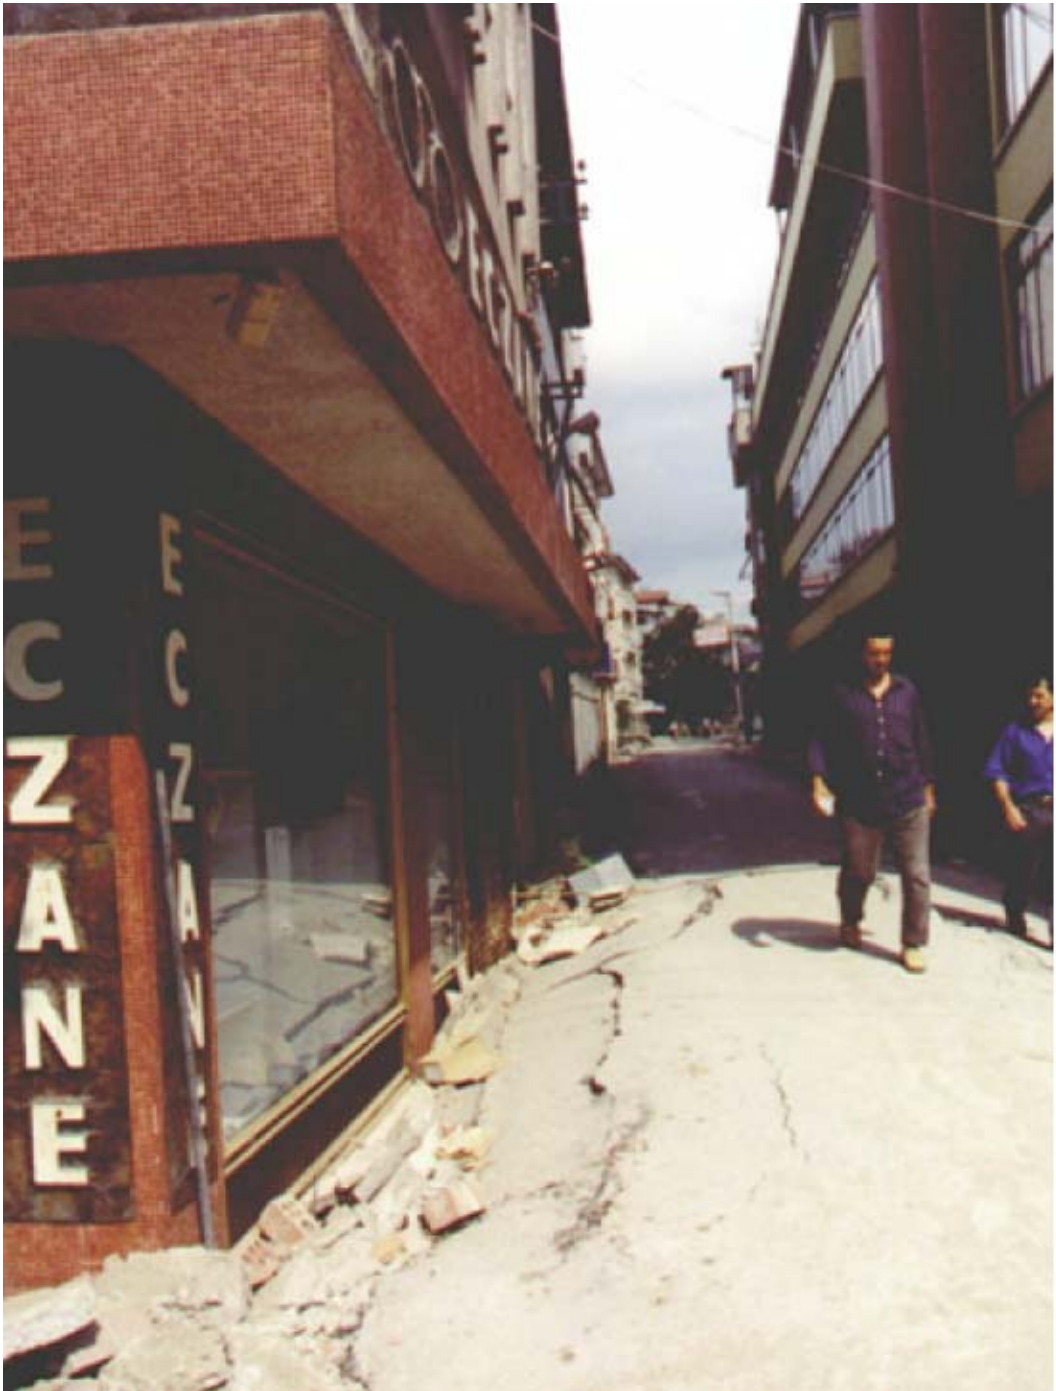
Partial liquefaction of the soil in Adapazari during the 1999 Kocaeli, Turkey earthquake caused several buildings to settle or fall over. [Figure 30.6](#) shows a building that settled as pore water was pushed to the surface, reducing the bearing capacity of the soil. Note that the weight of the building squeezed the weakened soil under the adjacent roadway.

**FIGURE 30.6** Settlement of building due to loss of bearing during the 1999 Kocaeli earthquake.

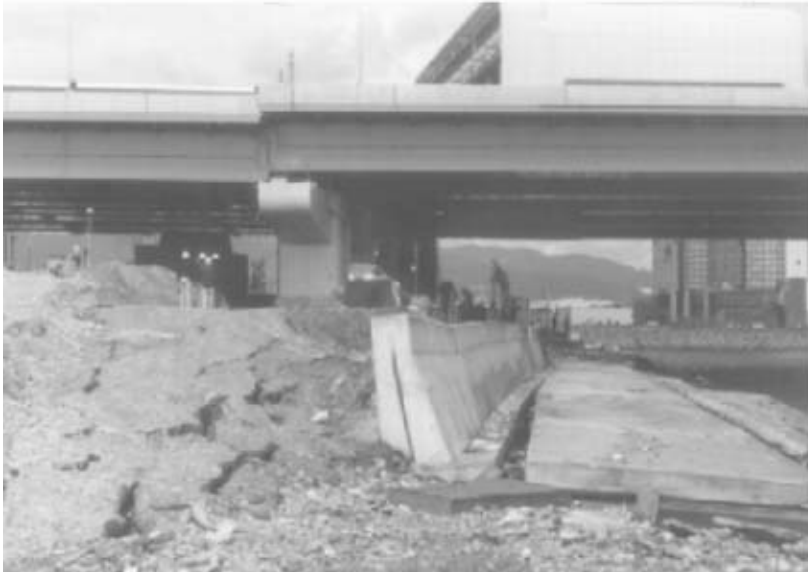
During the 1995 Kobe, Japan earthquake, increased pore pressure pushed the quay wall near the west end of the bridge toward the river, allowing the soil and western-most pier (Pier 134) to move one meter eastward ([Figure 30.7](#)). This resulted in the girders falling off their bearings, which damaged the expansion joint devices and made the bridge inaccessible. The eastern-most pier (Pier 131) moved half a meter

toward the river. It appears that the restrainers were the only thing that kept the superstructure together at the expansion joint above Pier 134, thus preventing the collapse of the west span. The expansion joint had a 0.6-m vertical offset, and excavation showed that the piles at Pier 134 were also damaged due to the longitudinal movement.

**FIGURE 30.7** Liquefaction-caused bridge damage during Kobe earthquake.

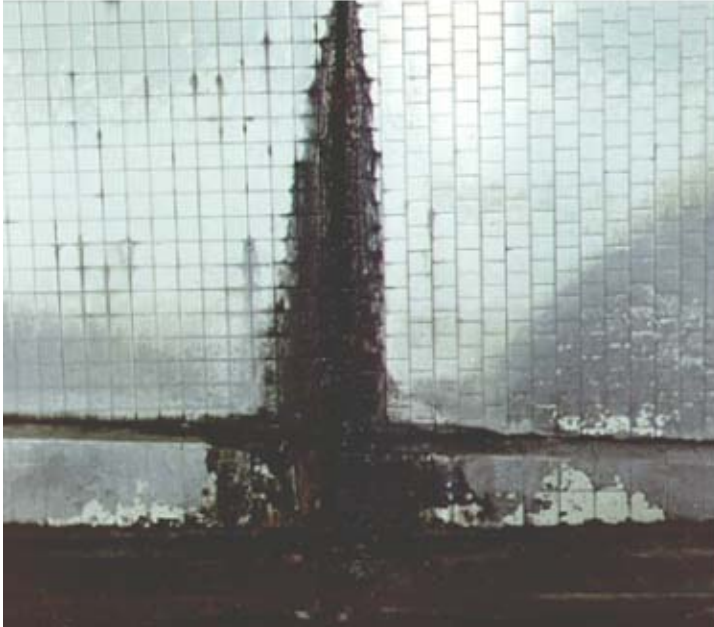
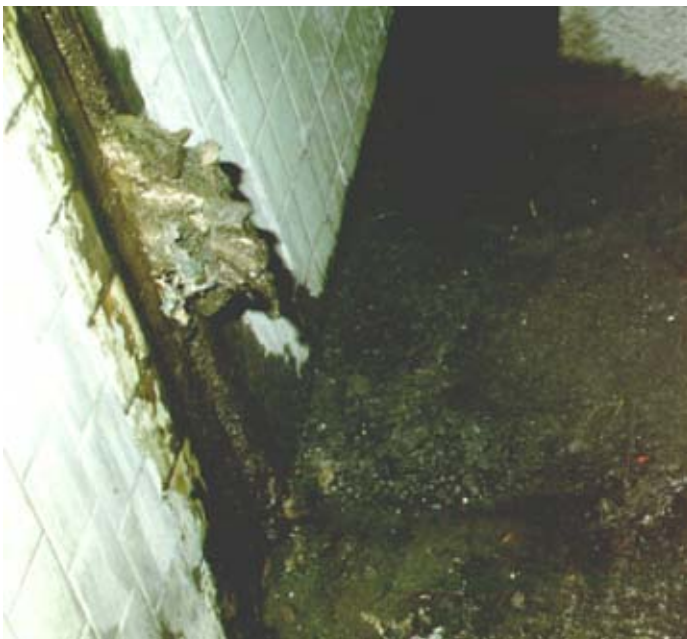
**FIGURE 30.10** Liquefaction-induced damage to Webster Street Tube tunnel.

tubes with a bituminous coating for waterproofing. The ground was excavated, and each tube section was joined to the previously laid section. Both tubes descend to 70 ft below sea level. During the 1989 Loma Prieta, CA, earthquake, the soil surrounding the Webster and Posey Tubes liquefied. The tunnels began to float to the surface, the joints between sections broke, and they slowly filled with water (Figures 30.10 and 30.11).

**FIGURE 30.11** Liquefaction-induced damage to Webster Street Tube tunnel.

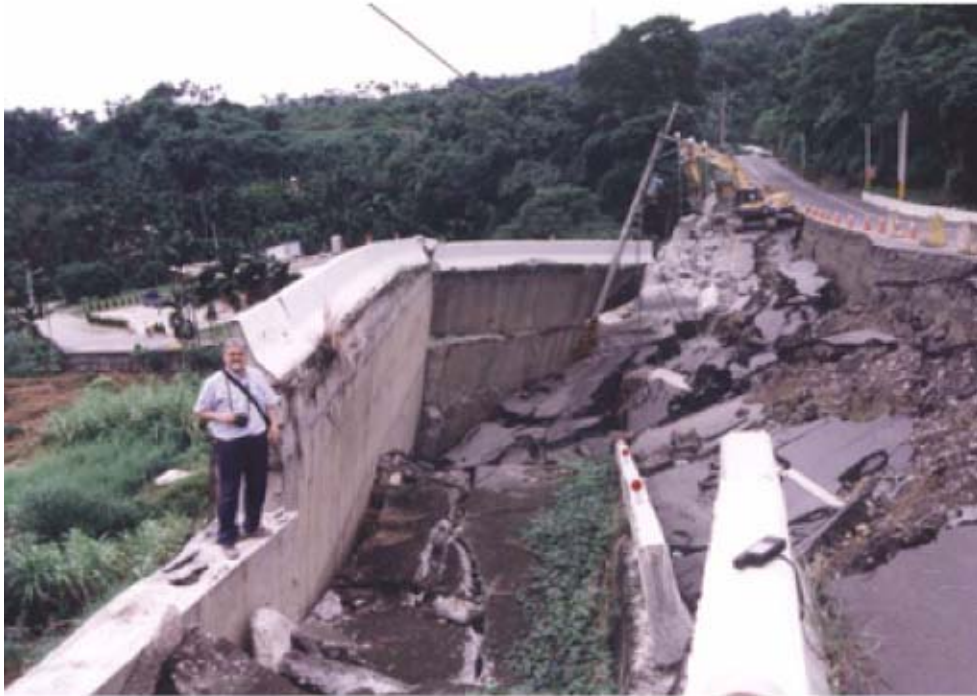
During the 1999 Ji Ji, Taiwan earthquake, many of the mountain slopes were denuded by slides which continued to be a hazard for people traveling the mountain roads in the weeks following the earthquake. The many reinforced concrete gravity retaining walls that supported the road embankments in the mountainous terrain were all damaged, either from being pushed downhill by the slide (Figure 30.13) or, in some cases, breaking when the retaining wall was restrained from moving downhill (Figure 30.14).

**FIGURE 30.13** Gravity retaining wall pushed outward by landslide.

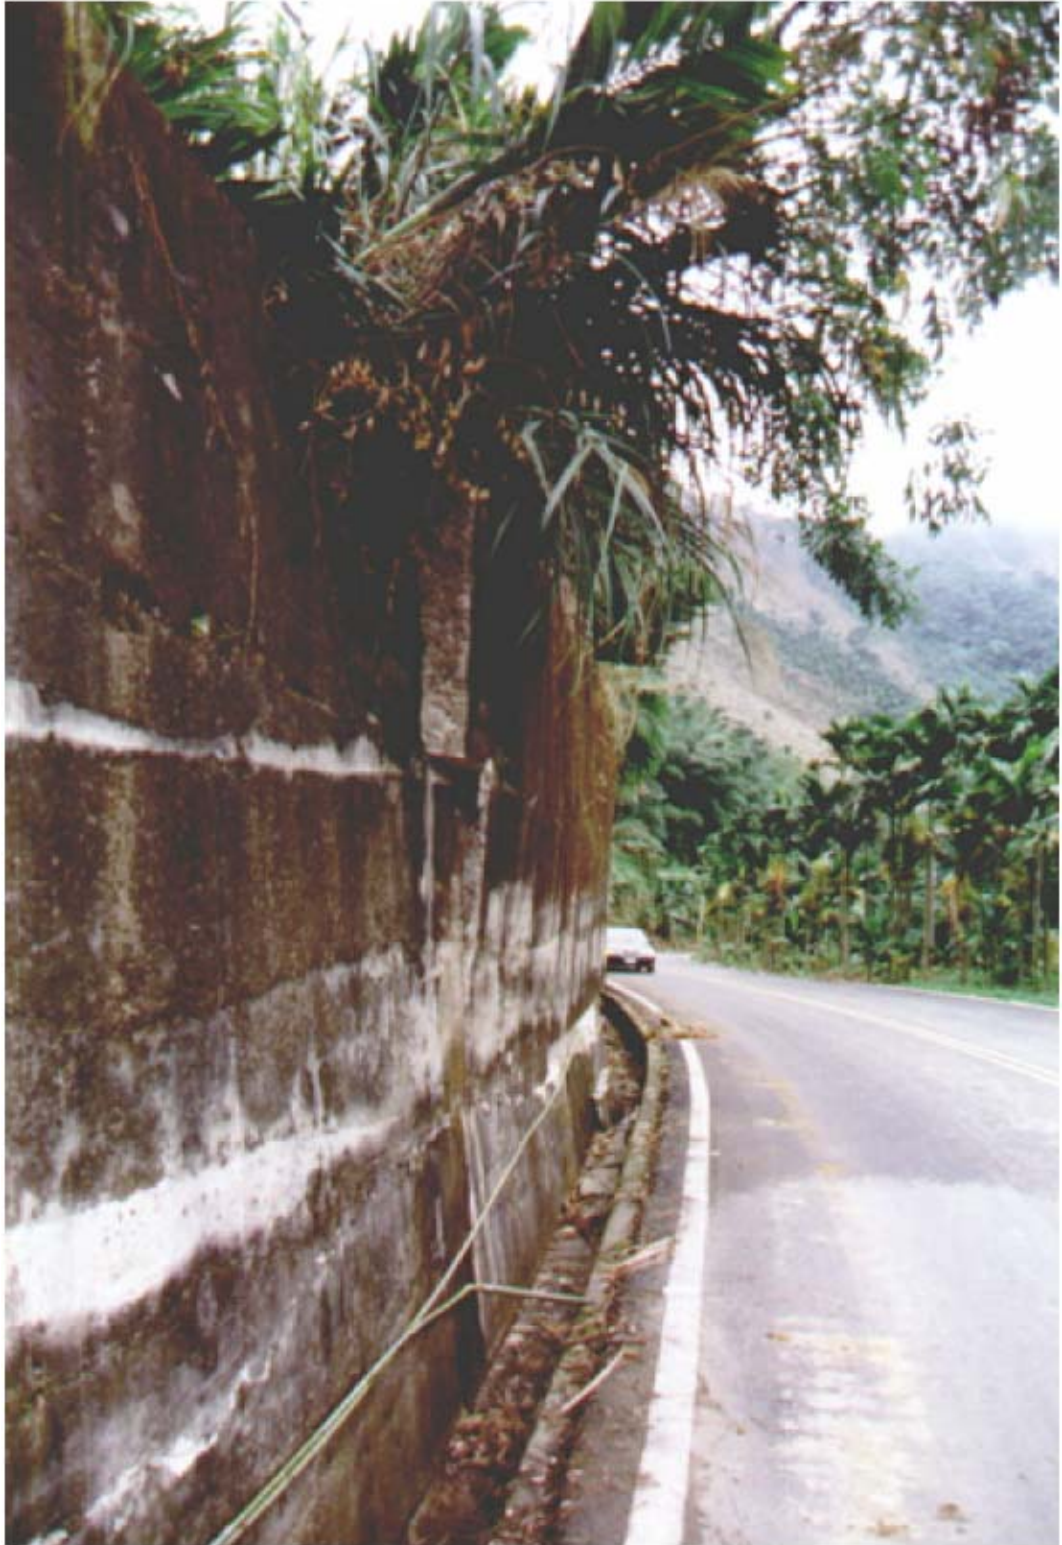
**FIGURE 30.14** Gravity retaining wall with shear damage from landslide.

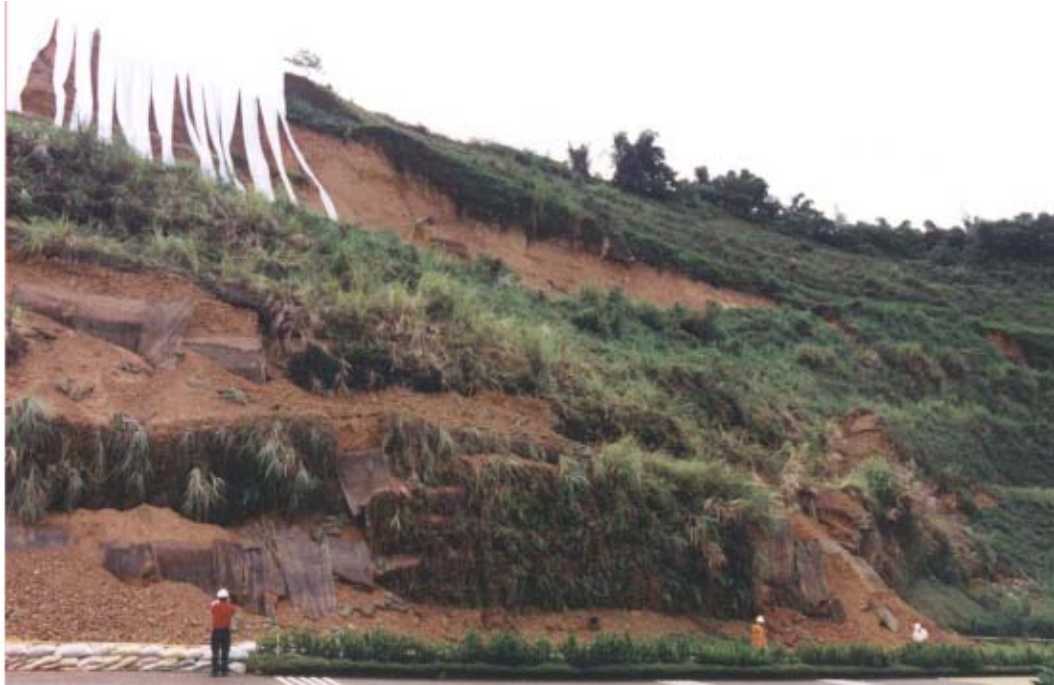
One of the more interesting retaining wall failures during the Ji Ji earthquake involved a geogrid fabric/mechanically stabilized earth (MSE) wall at the entrance to Southern International University (Figure 30.15). This wall was quite long and tall, and its failure was a surprise, as MSE walls have a good

FIGURE 30.15 Fabric retaining wall damaged during the 1999 Ji Ji, Taiwan earthquake.

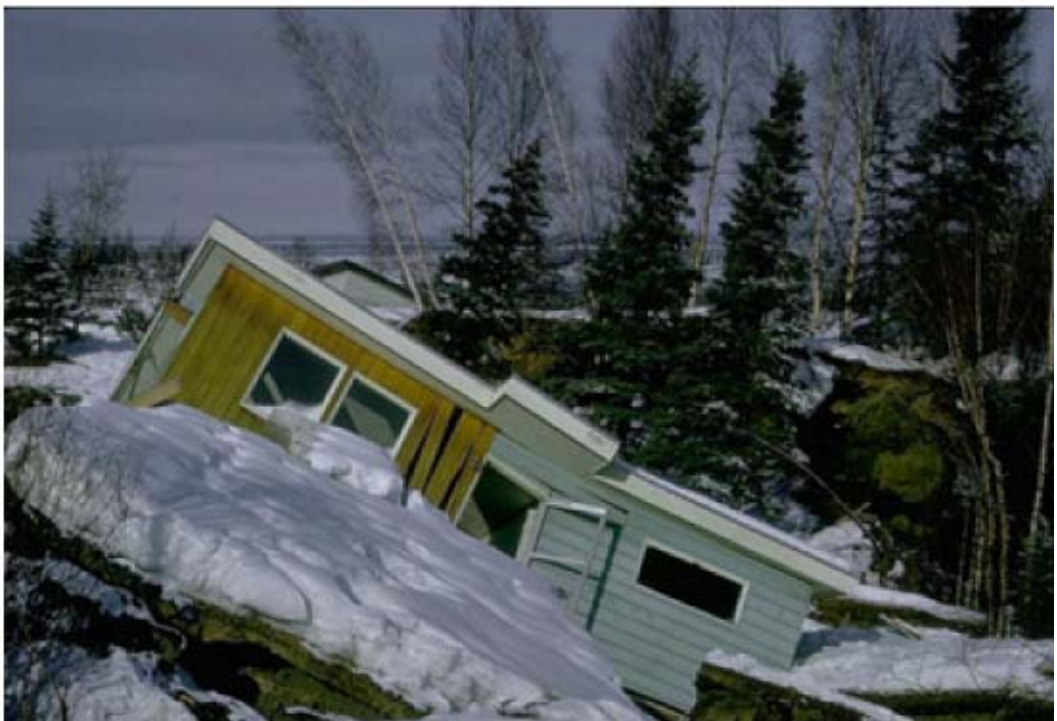
One of the best known and largest landslides occurred at Turnagain Heights in Anchorage during the 1964 Great Alaska earthquake. The area of the slide was about 8500 ft wide by 1200 ft long. The average drop was about 35 ft. This slide was complex, but the primary cause was the failure of the weak clay layer and the unhindered movement of the ground down the wet mud flats to the sea. [Figures 30.16](#) and [30.17](#) provide a section and plan view of the slide. The soil failed due to the intense shaking, and the whole neighborhood of houses, schools, and other buildings slid hundreds of yards downhill, many remaining intact during the fall ([Figure 30.18](#)).

FIGURE 30.18 One of about 75 homes damaged as a result of the Turnagain Heights slide. (Courtesy of the Steinbrugge Collection, Earthquake Engineering Research Center, University of California, Berkeley.)

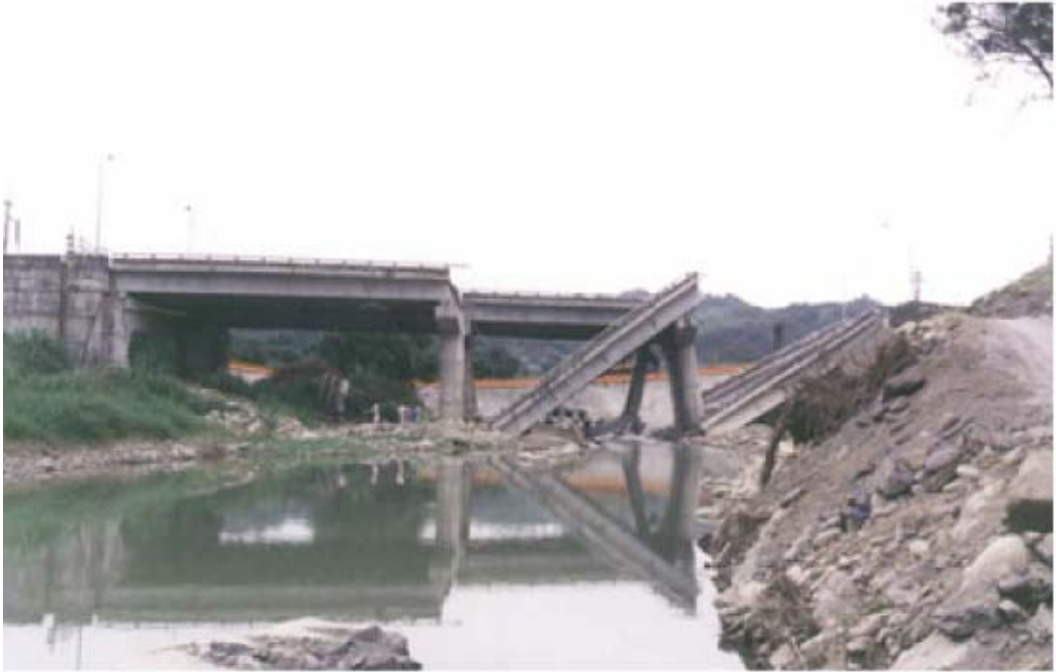
Bridges are also severely damaged by landslides. During the 1999 Ji Ji, Taiwan earthquake, landslides caused the collapse of two bridges. The Tsu Wei Bridges were two parallel, three-span structures that cross a tributary of the Dajia River near the city of Juolan. The superstructure was simply supported “T” girders on hammerhead single-column bents with “drum”-type footings and seat-type abutments. The girders sat on elastomeric pads between transverse shear keys. The spans were about 80 ft long by 46 ft wide, and had a 30-degree skew. The head scarp was clearly visible on the hillside above the bridge. During the earthquake, the south abutment was pushed forward by the landslide, the first spans fell off the bent caps on the (far) north side, and the second span of the left bridge also fell off of the far bent cap ([Figure 30.19](#)). Also, the tops of the columns at Bent 2 had rotated away from the (south) Abutment 1. Therefore, it appears that both the top of Abutment 1 and the top of Bent 2 moved away from the slide, while the remaining spans were restrained by Bent 3 and Abutment 4 and remained in place. Perhaps the landslide originally had pushed against Bent 2, rotating the columns forward, and the debris had since been removed by the current or by a construction crew. Perhaps the skew had rotated the spans to the right as they fell, pushing them against the shear keys at Bent 2, which rotated the top of the columns forward and eventually pushed the spans off the top of Bent 2 and Bent 3. Or, perhaps there was an element of strong shaking that combined with the landslide to create the column rotation and fallen spans.

**FIGURE 30.19** Collapse of Tsu Wei Bridge due to landslide during the Ji Ji, Taiwan earthquake.

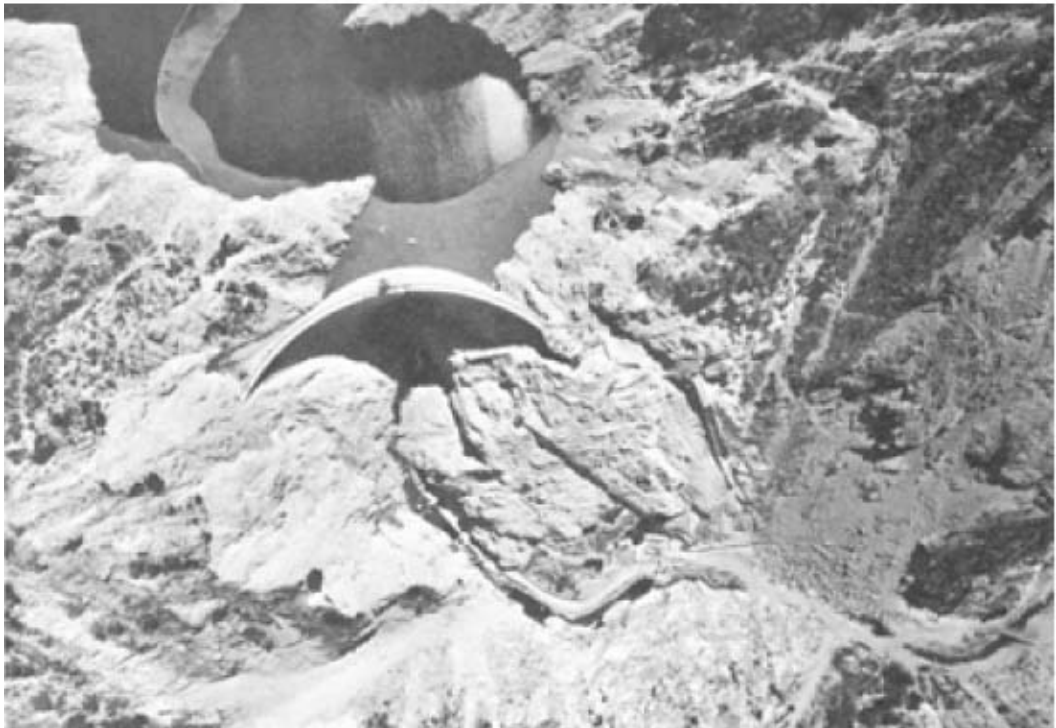
Dams are particularly vulnerable to landslides as they are frequently built to hold back the water in canyons and mountain streams. Moreover, inspection of the dam after an earthquake is often difficult when slides block the roads leading to the dam. When the Pacoima concrete arch dam was built in the 1920s, a covered tunnel was constructed to allow access to the dam. However, this tunnel and the roads and a tramway to the dam were damaged by massive landslides during and for several days after the 1971 San Fernando earthquake (Figure 30.20).

**FIGURE 30.20** Landslides at Pacoima Dam following the 1971 San Fernando earthquake. (Courtesy of Steinbrugge Collection, Earthquake Engineering Research Center, University of California, Berkeley.)

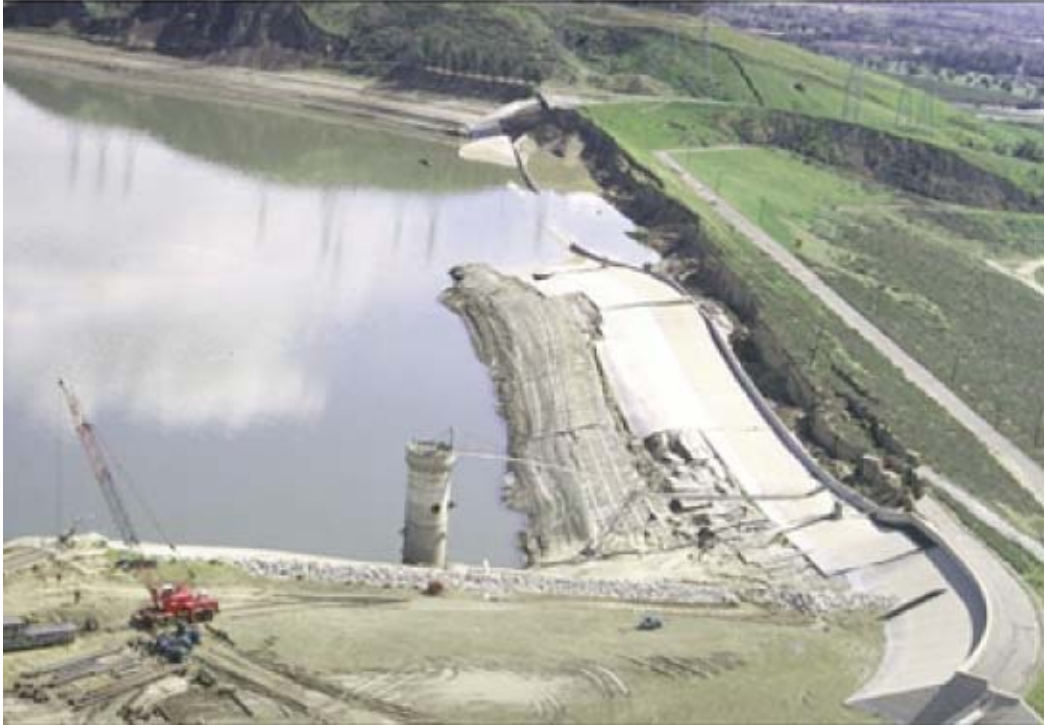
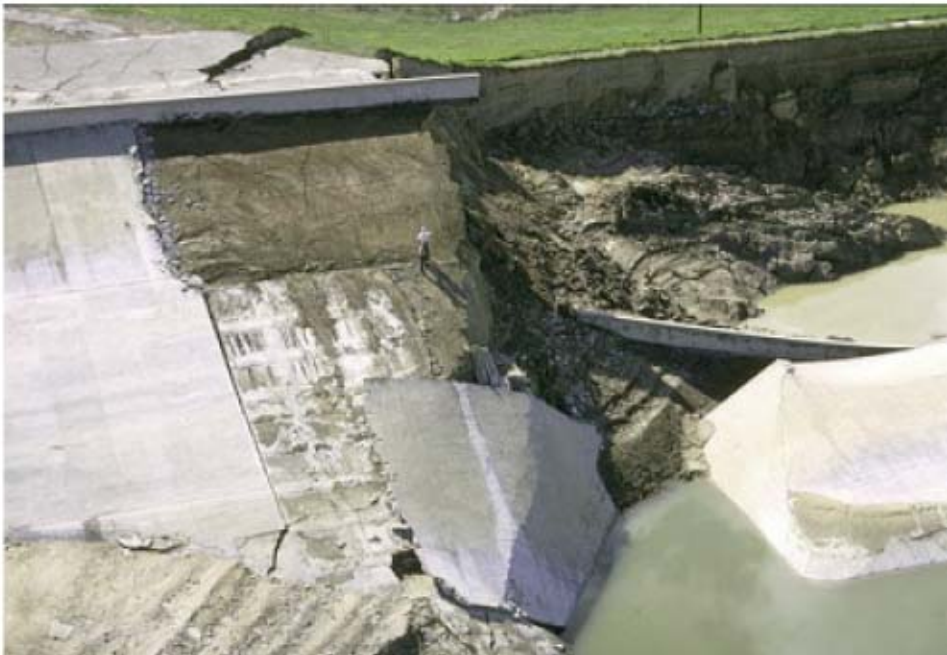
The Lower San Fernando Dam for the Van Norman Reservoir was also severely damaged during the 1971 San Fernando earthquake. It was fortunate that water levels were low, as the concrete crest on this earthen dam collapsed due to a large landslide along both the upstream (Figure 30.21) and downstream (Figure 30.22) faces. Considering the vulnerability of thousands of residences in the San Fernando Valley below (Figure 30.23), a dam failure can be extremely costly in terms of human lives and property damage.

**FIGURE 30.21** Damage to the Lower San Fernando Dam. (Courtesy of Steinbrugge Collection, Earthquake Engineering Research Center, University of California, Berkeley.)

**FIGURE 30.22** Closer view of damage to the Lower San Fernando Dam. (Courtesy of Steinbrugge Collection, Earthquake Engineering Research Center, University of California, Berkeley.)

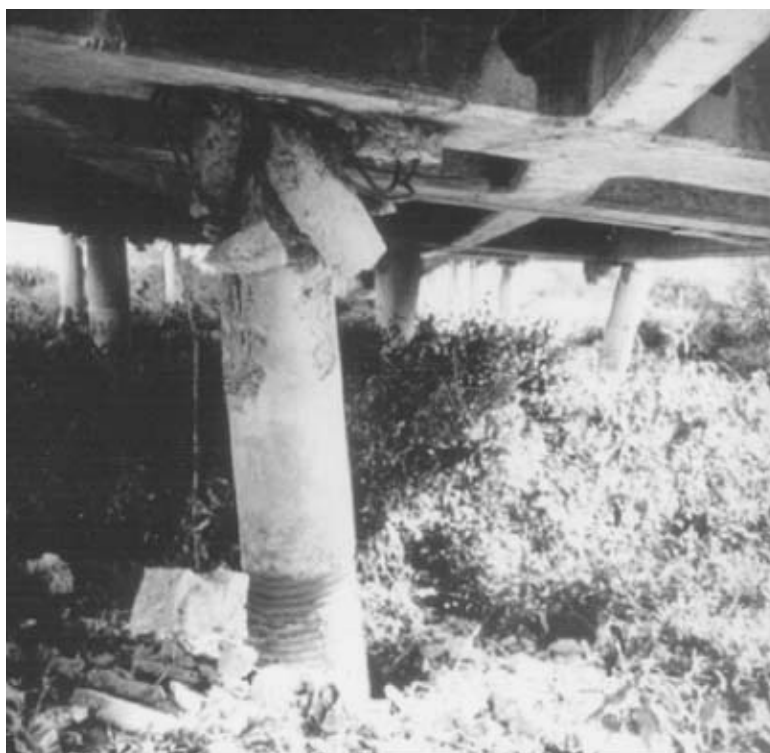
During the earthquake, the soft saturated soil in Struve Slough was violently shaken. The soil pushed against the piles, breaking their connection to the superstructure ([Figure 30.25](#)) and pushing them away from the cap beam so that they punctured the bridge deck ([Figure 30.26](#)). Investigators arriving at the bridge found shear damage at the top of the piles, indicating that the soil limited the point of fixity of the piles to near the surface. They also found long, oblong holes in the soil, indicating that the piles were dragged from their initial position during the earthquake. There was some thought that the damage at Struve Slough was the result of vertical acceleration, but the structure's vertical period of 0.20 seconds was too short to be excited by the ground motion at this site.

FIGURE 30.25 Broken piles under the bridge.

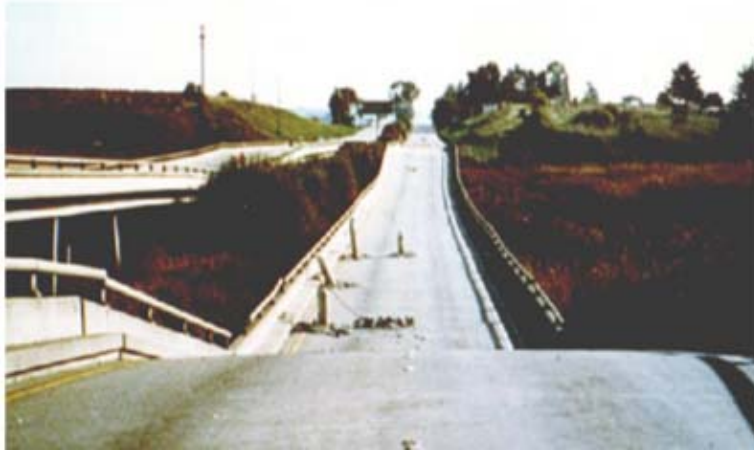
**FIGURE 30.26** Piles penetrating the bridge deck.

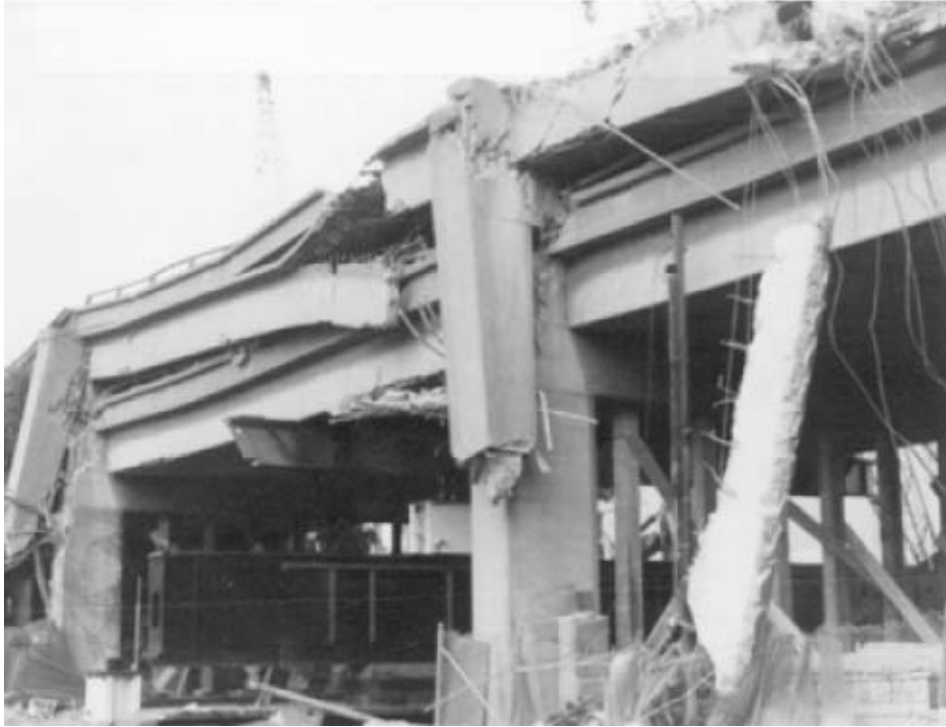
**FIGURE 30.28** Damage to Cypress Street viaduct.

collapse was the result of the weak pin connections at the base of the columns of the upper frame (Figure 30.28). There was inadequate confinement around the four #10 bars to restrain them during the earthquake; however, the soft Bay mud also played a role in the collapse. The southern portion of the bridge with the same vulnerable details, but supported on sand, remained standing. The northern portion was supported by soft Bay mud that was sensitive to the long period motion and caused large movements that overstressed the pinned connections (Figure 30.29).

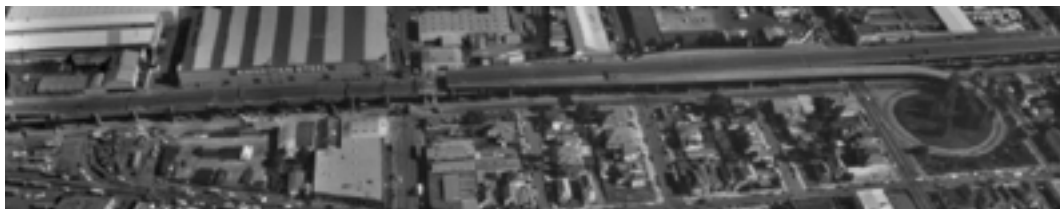
**FIGURE 30.29** Aerial view of Cypress Street Viaduct showing collapse at north end (left) where the structure crossed over Bay mud, while the southern part (right), supported by dense sand, remained standing.

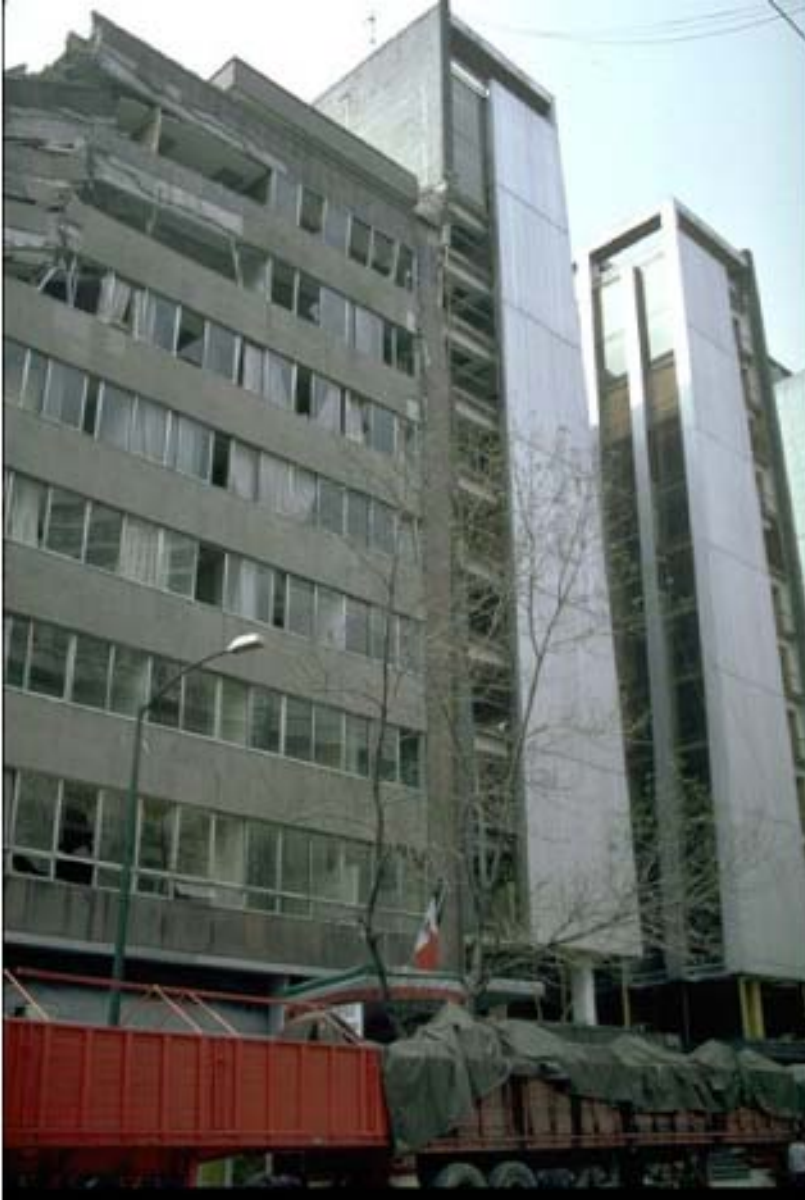
**FIGURE 30.31** Damaged 10-story building between the Plaza de la Constitution and Zona Rosa in Mexico City. (Photograph by Karl Steinbrugge and courtesy of the Steinbrugge Collection, Earthquake Engineering Research Center, University of California, Berkeley.)

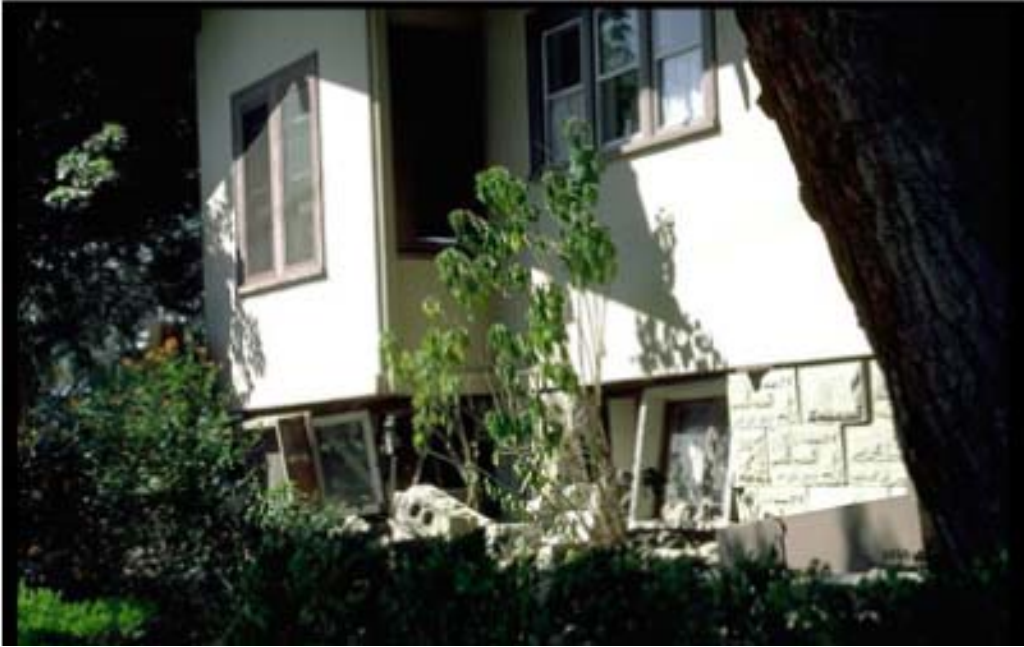
Usually, it is the connection to the foundation or an adjacent member rather than the foundation itself that is damaged during a large earthquake; however, materials that cannot resist lateral forces (such as hollow masonry blocks) make a poor foundation and their use should be avoided ([Figure 30.32](#)). Engineers

**FIGURE 30.32** Hollow concrete-block foundation that failed during the magnitude 6.0 1987 Whittier, CA earthquake. (Photograph by Karl Steinbrugge and courtesy of the Steinbrugge Collection, Earthquake Engineering Research Center, University of California, Berkeley.)

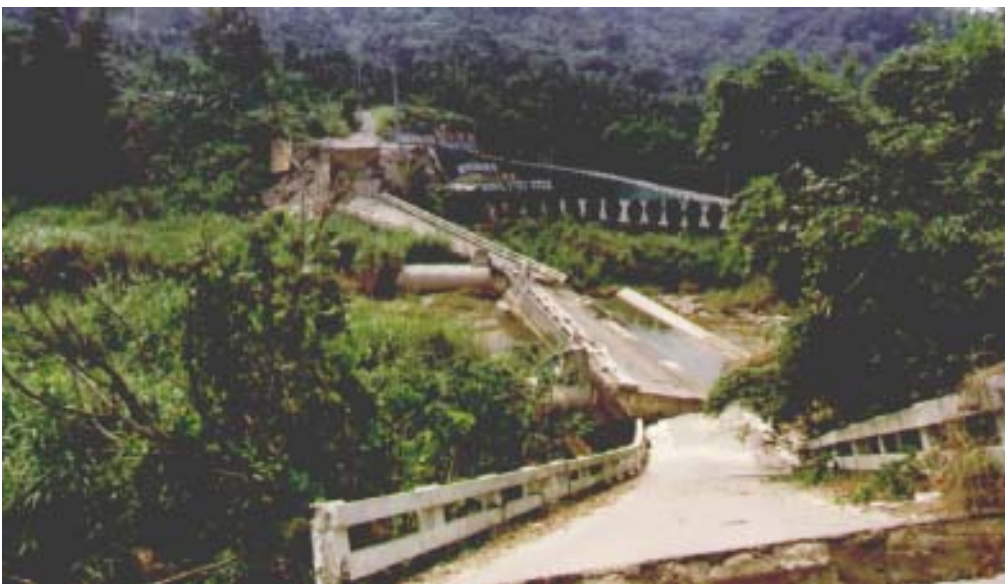
will occasionally design foundations to rock during earthquakes as a way of dissipating energy and of reducing the demand on the structure; however, when the foundation is too small, it can become unstable and rock over. During the 1999 Ji Ji, Taiwan earthquake (magnitude 7.6), a local three-span bridge rocked over transversely due to small, drum-shaped footings that provided little lateral stability ([Figure 30.33](#)).

**FIGURE 30.33** Three-span bridge rocked over during the 1999 Ji Ji, Taiwan earthquake.

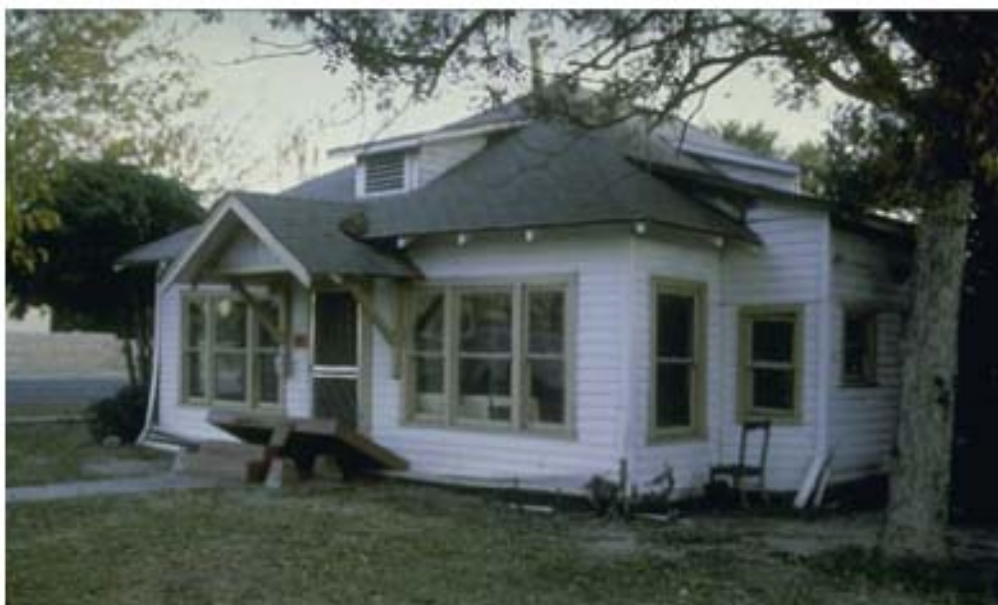
The major cause of damage to electrical transformers, to storage bins, and to a variety of other structures and lifeline facilities during earthquakes is the lack of a secure connection to the foundation. Houses need to be anchored to the foundation with hold-downs connected to the stud walls and anchor bolts connected to the sill plates. Otherwise, the house will fall off its foundation, as shown in [Figure 30.34](#).

**FIGURE 30.34** House that fell from its foundation during the 1971 San Fernando earthquake. (Courtesy of Steinbrugge Collection, Earthquake Engineering Research Center, University of California, Berkeley.)

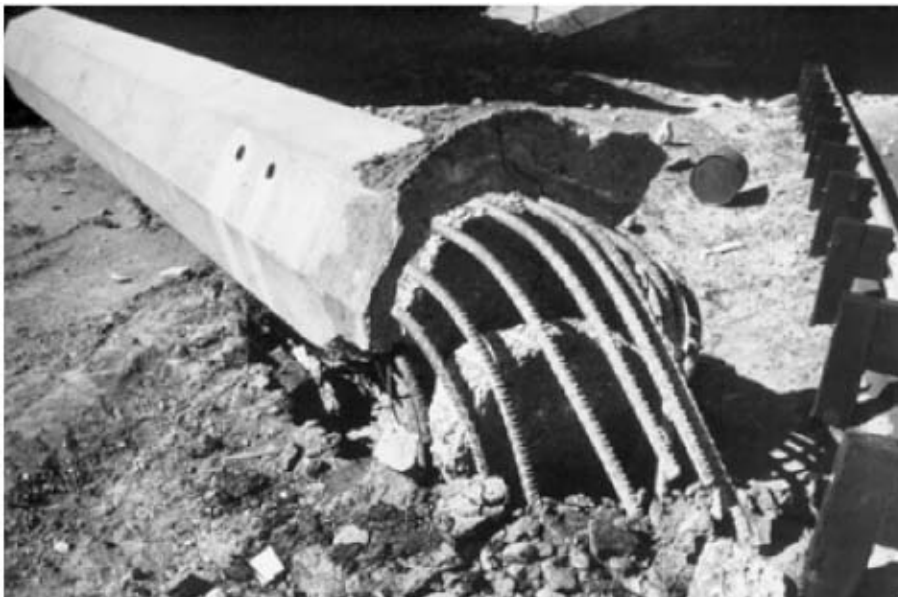
**FIGURE 30.35** Failure of connection of column to pile shaft.

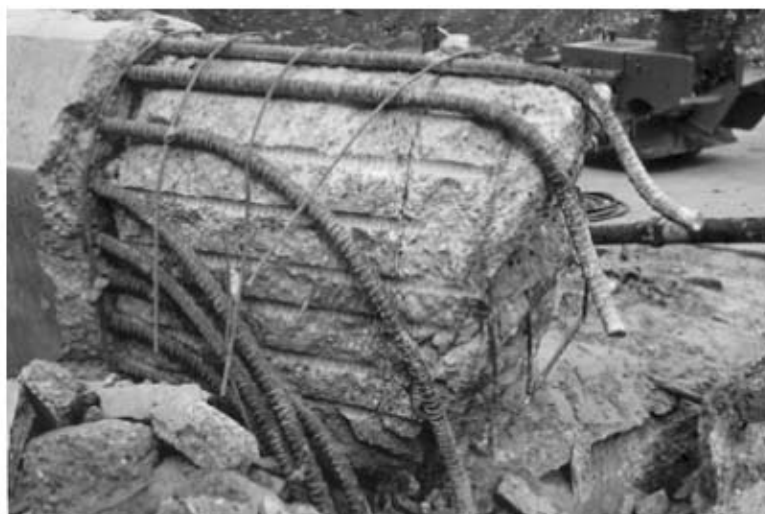
**FIGURE 30.36** Failure of connection of column to footing.

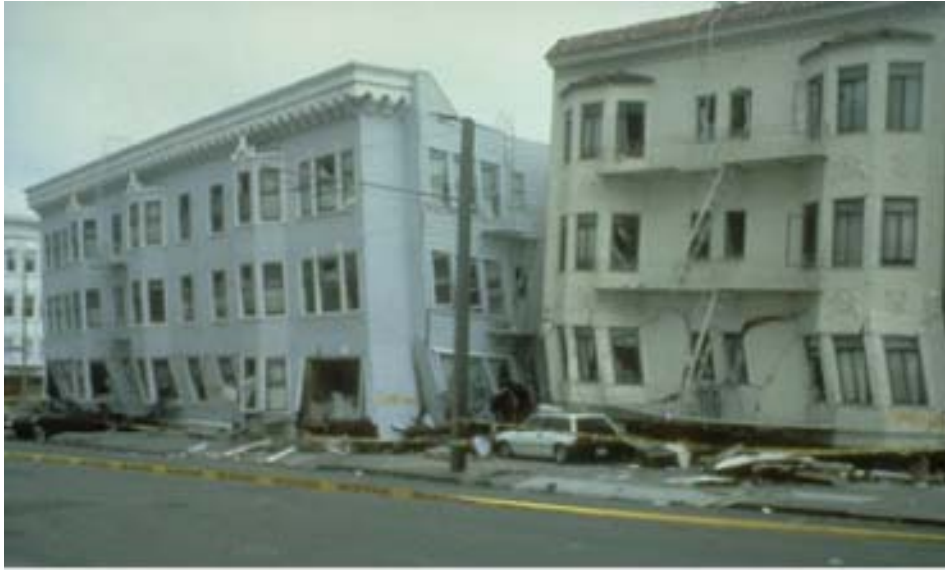
During the 1989 Loma Prieta earthquake, many houses and apartment buildings in the San Francisco area had severe damage to the ground floor. These structures had less lateral support on the ground floor to allow room for cars to park under the structure. The remaining supports could not support the movement of the upper stories, which dropped onto the ground (Figure 30.37).

**FIGURE 30.37** Soft-story collapse in San Francisco during the 1989 Loma Prieta earthquake. (Courtesy of the U.S. Geological Service [10].)

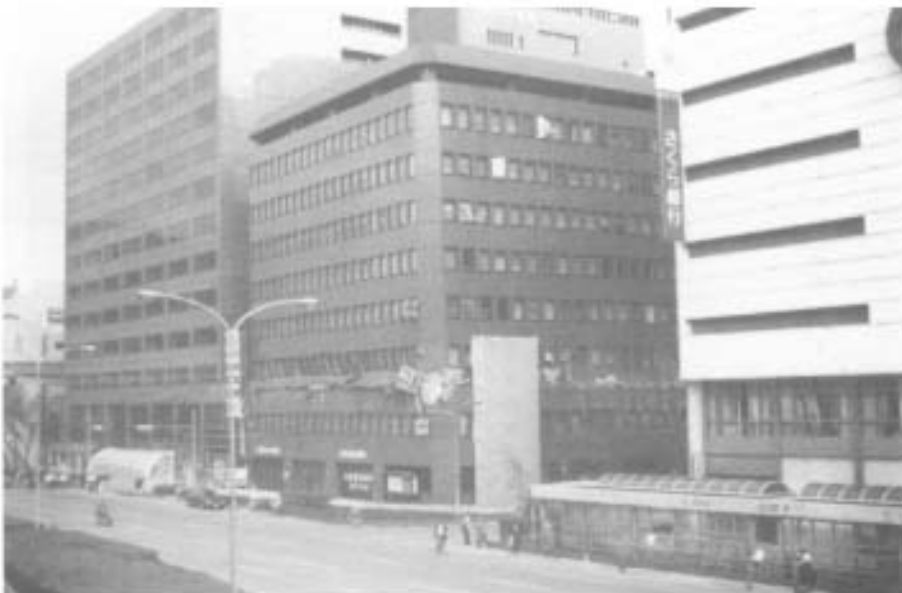
A soft story, however, does not always occur on the bottom floor. During the 1995 Kobe, Japan earthquake, many tall buildings had mid-story damage, often due to designing the upper floors for a reduced seismic load. Most buildings in Japan are either built of reinforced concrete (RC) or of steel and reinforced concrete (SRC). These SRC buildings, when correctly designed, provide a great deal of ductility and more fire protection during large earthquakes. However, the design practice in Japan was to discontinue either the reinforced concrete or the steel above a certain floor. [Figure 30.38](#) shows typical details used in SRC buildings. [Figure 30.39](#) shows a ten-story SRC building where the third story collapsed during the 1995 Kobe earthquake.

**FIGURE 30.39** Ten-story steel and reinforced-concrete (SRC) building with third-floor collapse during the Kobe earthquake. (Courtesy of NIST [9].)

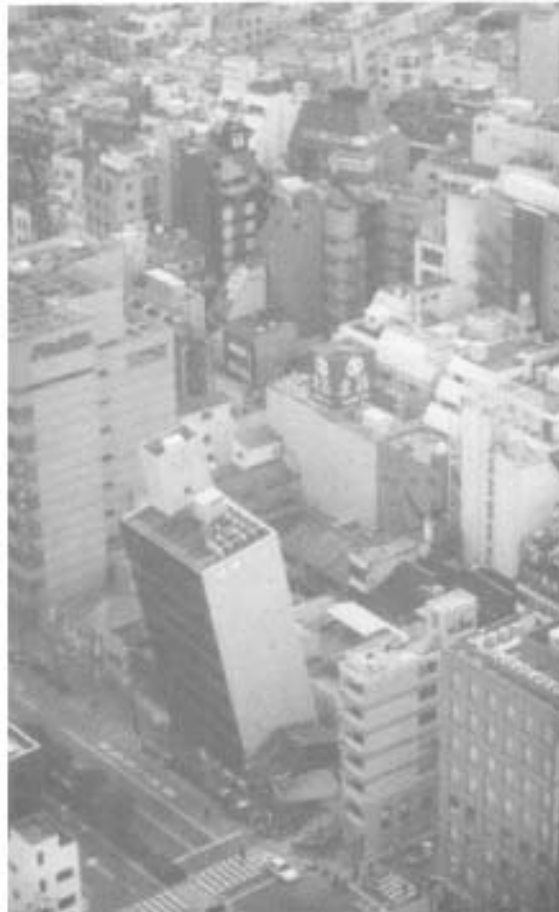
Curved, skewed, and eccentrically supported structures often experience a torsional moment during earthquakes. A nine-story building in Kobe, Japan, consisted of shear walls along three sides and a moment-resisting frame on the fourth (east) side ([Figure 30.40](#)). Shaking during the 1995 Kobe earthquake caused a torsional moment in the building. The first-story columns on the east side failed in shear, the building leaned to the east ([Figure 30.41](#)), and it eventually collapsed ([Figure 30.42](#)).

**FIGURE 30.41** Nine-story steel and reinforced-concrete (SRC) building immediately after the 1995 Kobe earthquake. (Courtesy of NIST [9].)

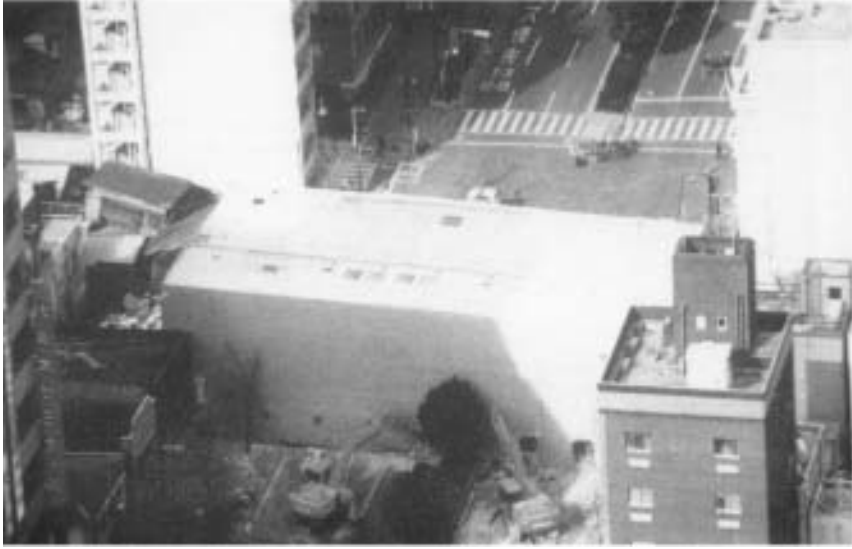
**FIGURE 30.42** Eventual collapse of nine-story steel and reinforced-concrete (SRC) building after the Kobe earthquake. (Courtesy of NIST [9].)
