Yashinsky, M. "Earthquake Damage to Structures"  
*Structural Engineering Handbook*.  
Ed. Lian Duan  
Boca Raton: CRC Press LLC, 2001

# Earthquake Damage to Structures

Mark Yashinsky  
*Caltrans Office of  
Earthquake Engineering*

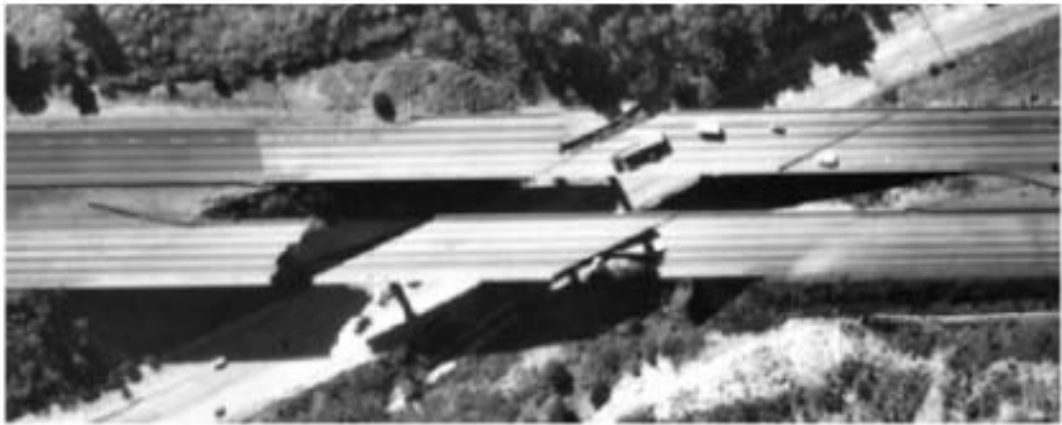
During the 1994 Northridge earthquake, the superstructures unseated due to the following factors. The tall, center-frame had a large, long-period motion that was out of phase with the stiff end-frames. The center of stiffness of the end-frame was near the abutment, while its mass was near the bent, causing the end-frame to twist about the abutment. The sharp skew allowed the acute corners to slide off the

narrow seats. The cable restrainers, one of the first used in this country, were grouted in the ducts, making them too brittle and prone to failure. Both bridges failed, as shown in [Figure 30.43](#).

**FIGURE 30.43** Damage to Gavin Canyon Undercrossing during the 1995 Northridge earthquake.

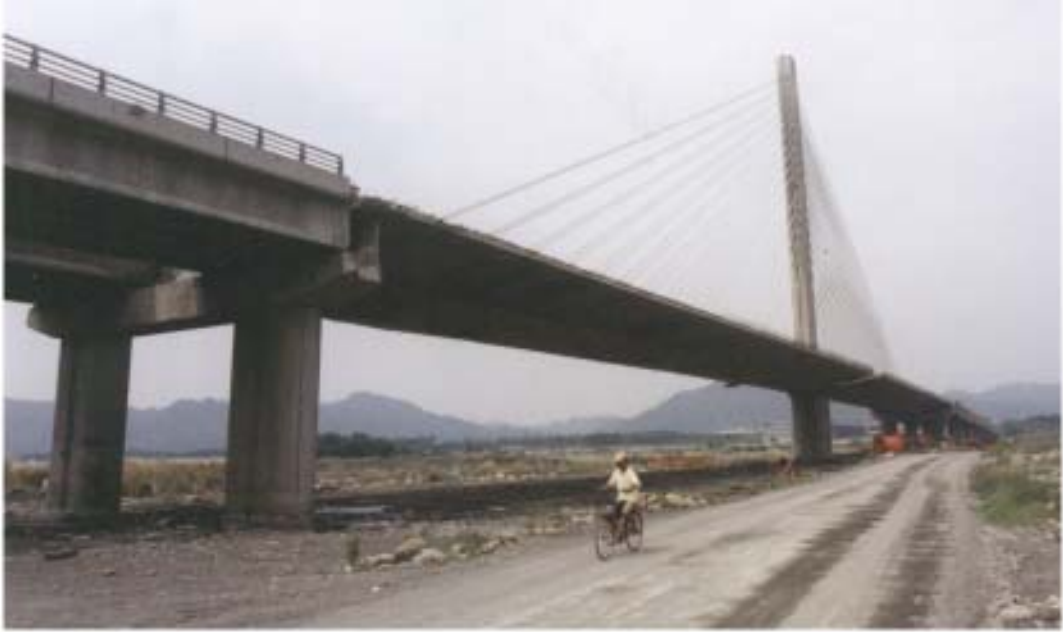
(Figure 30.44). The distance from the top of the deck to the top of the tower is 58 m; from top of the footing to the soffit, 20 m. All the foundations are supported on driven piles. Construction was almost completed on this bridge at the time of the earthquake. All of the cables had been tensioned and all but one had been permanently socketed into the tower. The false work had been pretty much removed except for a few final pours for the portion of the superstructure where it connects to the tower.

**FIGURE 30.44** The Ji Lu cable-stayed bridge after the 1999 Taiwan earthquake.

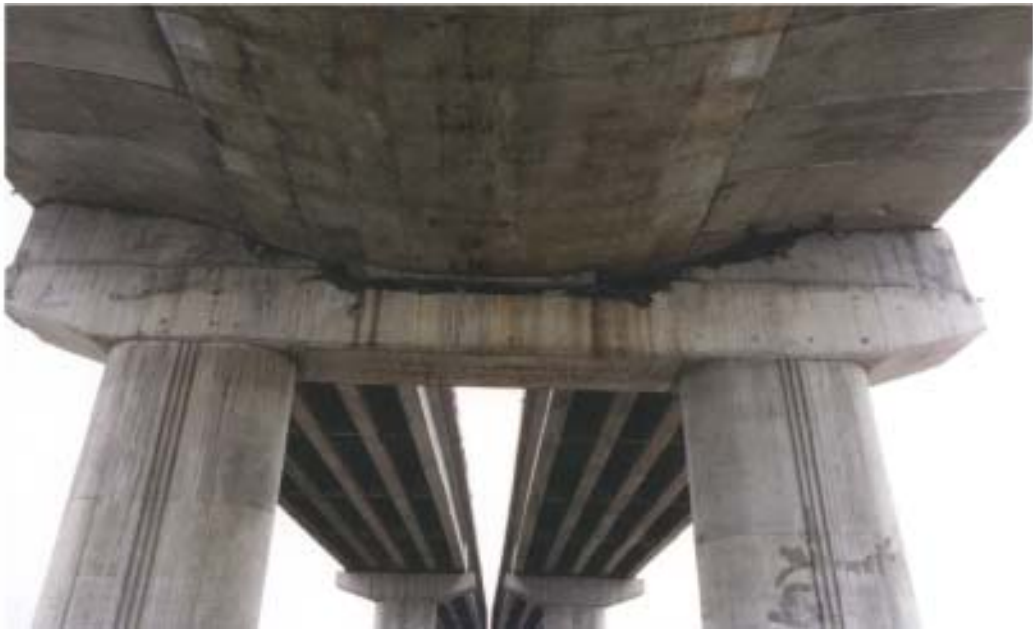
**FIGURE 30.45** Damage at end-supports to Ji Lu cable-stayed bridge.

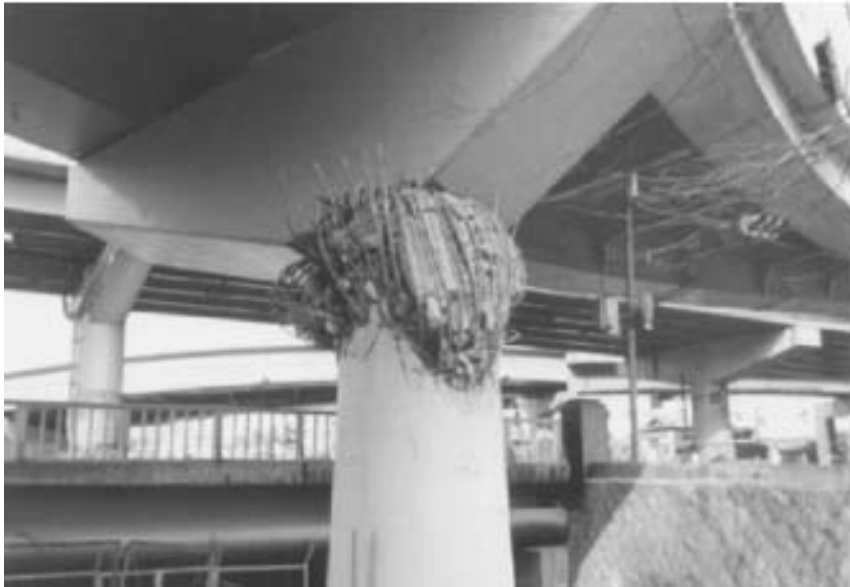
suffered severe torsional damage ([Figure 30.46](#)). As one member of a bridge goes into flexure it can create large torsional moments in adjacent members. For instance, flexure in the columns of outrigger bents causes large torsional moments in the bent cap ([Figure 30.47](#)). All of these examples reinforce the idea that most structures require consideration of all three translations and rotations.

**FIGURE 30.46** Column damage to the Minatogawa Interchange during the Kobe earthquake.

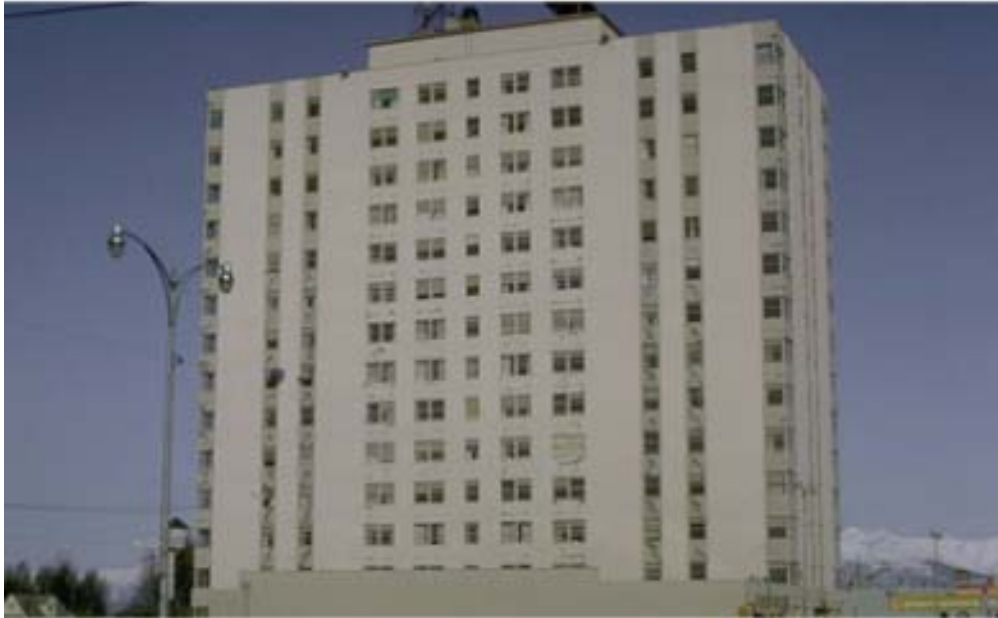
Most building structures use shear walls or moment-resisting frames to resist lateral forces during earthquakes. Damage to these systems varies from minor cracks to complete collapse. [Figure 30.48](#) is a photo of the Mt. McKinley Apartments after the 1964 Great Alaska earthquake. The 14-story, reinforced-concrete building was composed of narrow exterior shear walls and spandrel beams ([Figure 30.48](#)), as well as interior and exterior columns and a central tower. During the 1964 earthquake, this structure suffered major structural damage to most of the load-bearing members.

**FIGURE 30.48** West elevation of Mt. McKinley Apartments after the 1964 Great Alaska earthquake. (Photograph by Karl Steinbrugge and courtesy of the Steinbrugge Collection, Earthquake Engineering Research Center, University of California, Berkeley.)

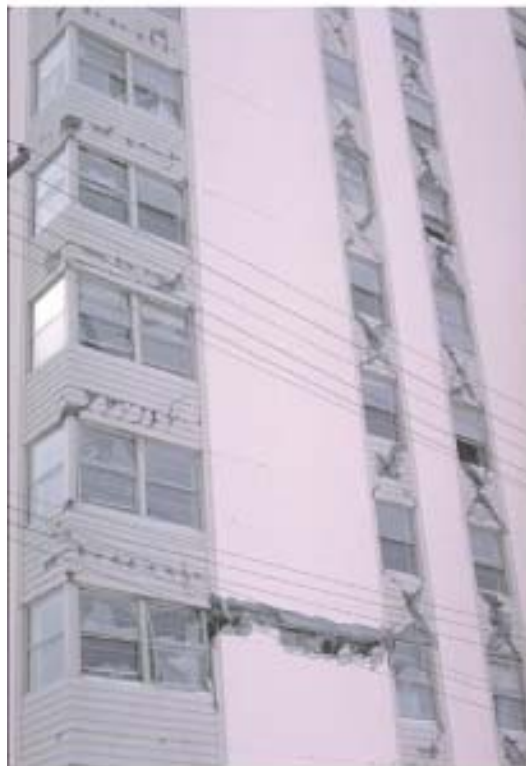
The most serious damage was to a shear wall on the north side of the building ([Figure 30.49](#)). A very wide shear crack split the wall in two, directly under a horizontal beam. This crack was a result of not having enough transverse reinforcement to hold the wall together as it moved transversely and was also due to a cold joint in the concrete at that location. The spandrel beams between the walls had large “X” cracks associated with shear damage as the building moved back and forth. These cracks decreased in size on the upper floors.

**FIGURE 30.49** Damage to north side of Mt. McKinley Apartments. (Photograph by Karl Steinbrugge and courtesy of the Steinbrugge Collection, Earthquake Engineering Research Center, University of California, Berkeley.)

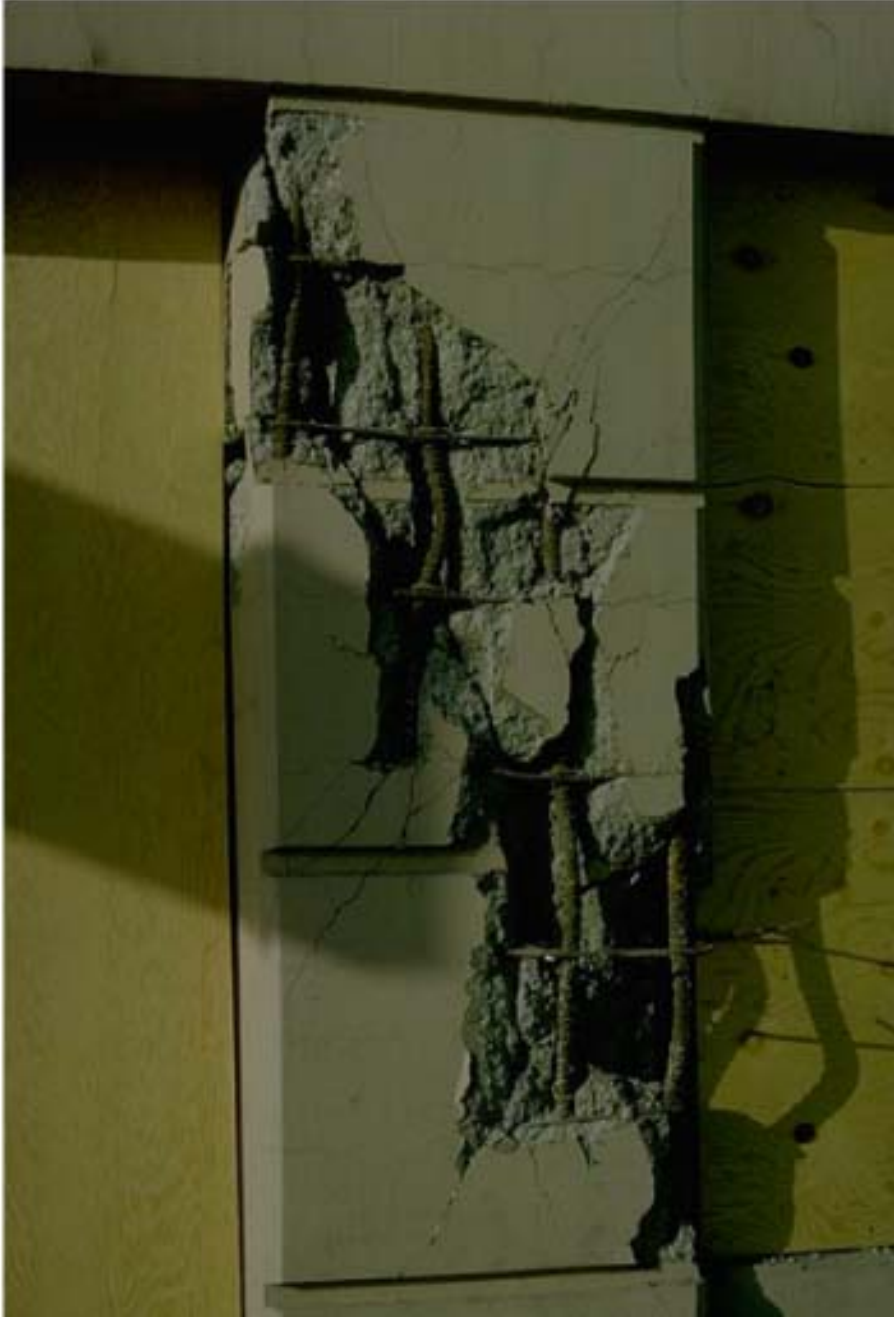
There was also shear damage to many of the columns. [Figure 30.50](#) is one of the exterior columns on the south side of the building with a diagonal shear crack. Again, the problem was insufficient transverse reinforcement to resist the large shear forces that occurred during the earthquake. The central tower was

**FIGURE 30.50** Damage to the south side of Mt. McKinley Apartments. (Photograph by Karl Steinbrugge and courtesy of the Steinbrugge Collection, Earthquake Engineering Research Center, University of California, Berkeley.)

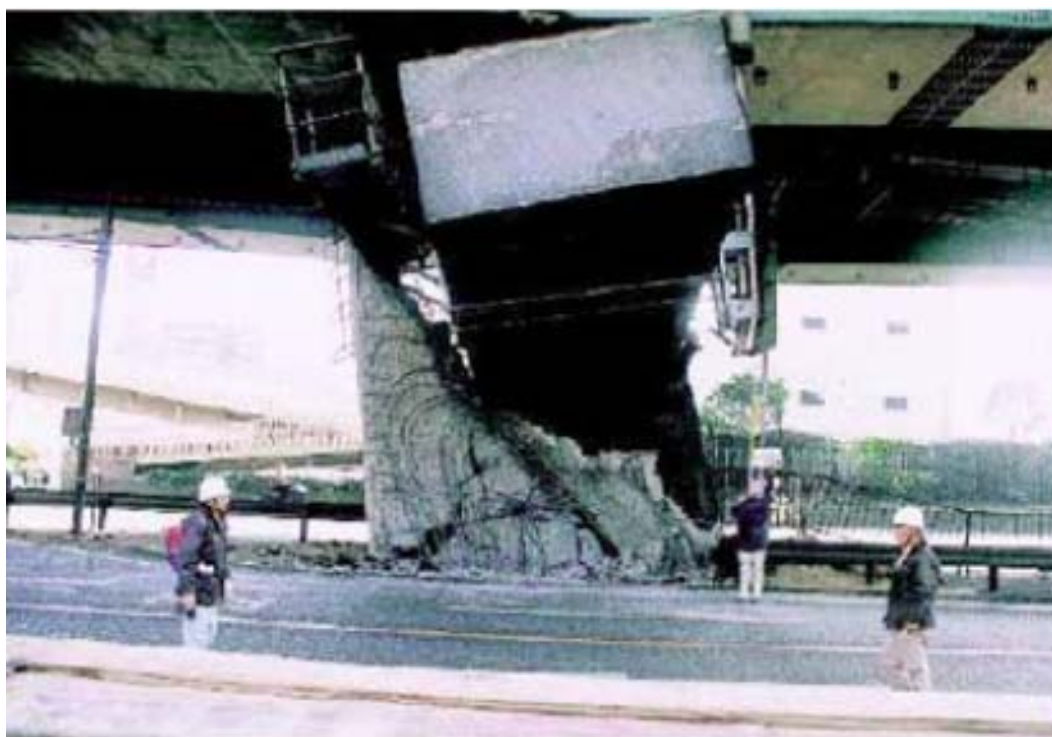
**FIGURE 30.51** Shear failure of Pier 150 on Kobe Route 3.

Figure 30.51 shows the shear failure at Pier 150. This damage was the result of insufficient transverse reinforcement and poor details. During the large initial jolt (amplified by near-field directivity effects), the transverse reinforcement came apart and resulted in failure of the column due to shear. Pier 149 was also severely damaged, but, because it was taller (and more flexible), most of the force went to stiff Pier 150. The three-span continuous superstructure survived the collapse of Pier 150 with minor damage.

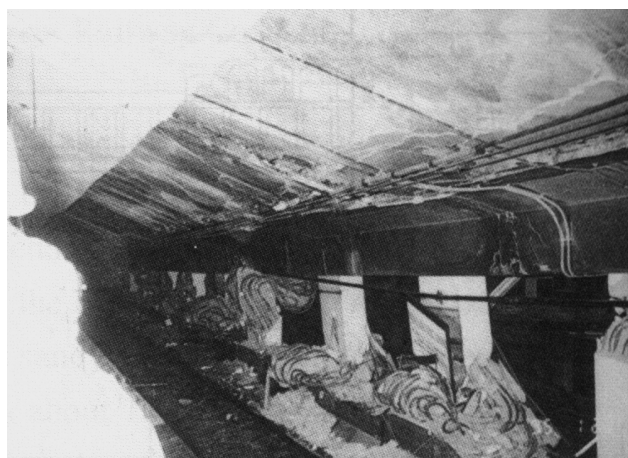
The Dakkai subway station in Japan is a two-story, underground, reinforced-concrete structure. It was constructed by removing the ground, building the structure, and then covering it (the-cut-and-cover method). During the 1995 Kobe earthquake, the center columns on both levels suffered a combination of flexural and compression damage that caused both roofs to collapse along with a roadway that ran above the station (Figure 30.52). Figure 30.53 shows the rather slender center columns at the lower level after the earthquake. The columns had insufficient transverse reinforcement at the location of maximum moment. The transverse reinforcement broke as the columns were displaced, allowing the longitudinal reinforcement to buckle and the concrete to fall out of the column.

**FIGURE 30.53** Flexural damage to columns at lower-level of Dakkai Subway during the 1995 Kobe earthquake. (Courtesy of Japan Society of Civil Engineers [5].)

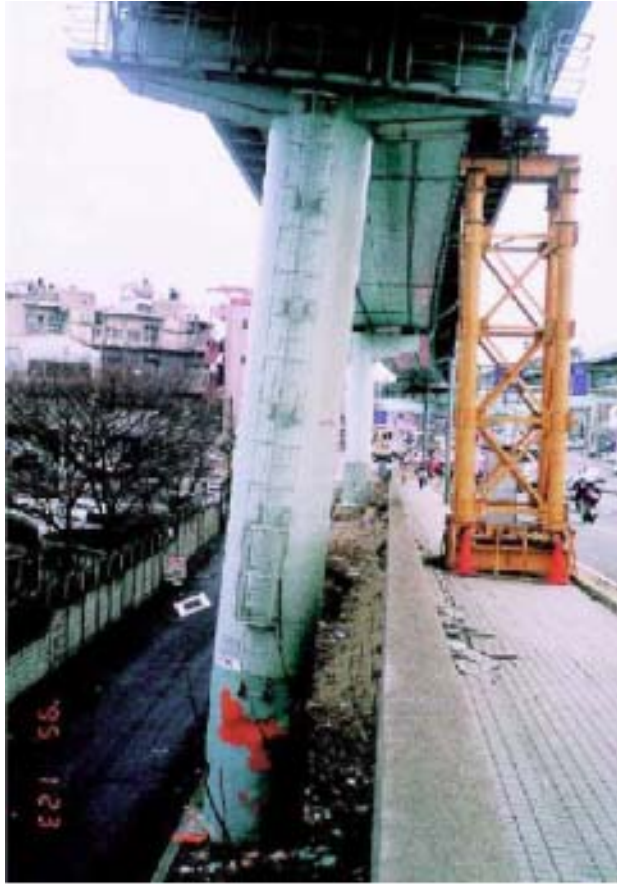
Steel columns experience similar damage when the flexural demand exceeds the capacity. In downtown Kobe, in the Nagata District, Route 3 splits into two parallel structures, with the superstructure composed of 50-m long, simple spans with steel girders and a three-span continuous steel box girder section between Piers 585 and 588. The substructure is comprised of 2.2-m diameter, 14-m tall, steel, hammerhead single columns. The steel columns are bolted onto 4-m diameter, 20-m long, hollow concrete shafts. The column bottoms are filled with concrete to protect against vehicular impact. During the Kobe earthquake, these steel columns had damage varying from local buckles to a complete section buckle, and, at a few locations, the steel shell had torn, splitting the column. Most of the buckling occurred in a thinner section of the column. In some cases (Figure 30.54), the column underwent an excursion in only one direction and consequently had a buckle on one side of the column. In some cases, the buckled face tore in the tension cycle (Figure 30.55). The tears occurred in low ductility welds. After the earthquake, the columns were tilting dangerously to the side. Buckling occurred before a plastic hinge was formed. A few columns remained undamaged as a result of failed bearings. Although local buckling cannot be completely eliminated, its spread can be prevented by maintaining smaller  $b/t$  ratios. This is accomplished through thicker sections, more frequent stiffeners and diaphragms, or filling the steel shells with lightweight concrete.

**FIGURE 30.54** Pier 585 on Kobe Route 3 during the 1995 Kobe earthquake. (Courtesy of Hanshin Expressway Public Corporation.)

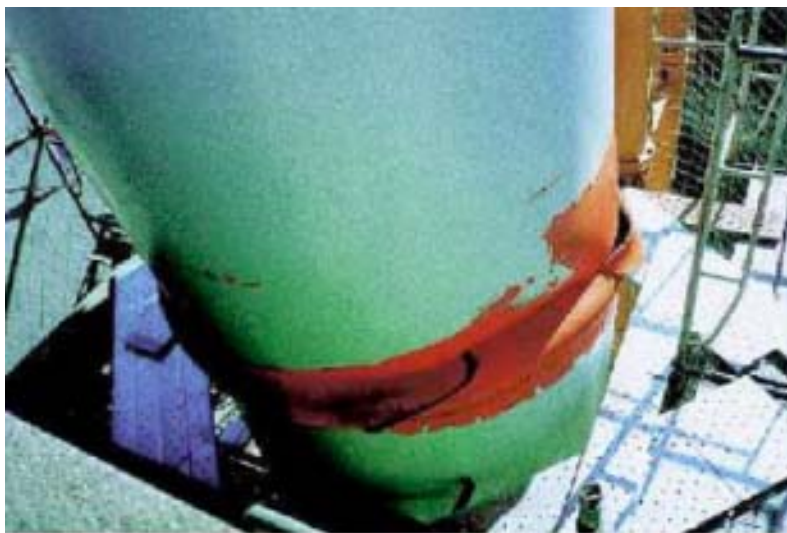
**FIGURE 30.55** Torn buckle of steel column on Route 3 after the 1995 Kobe earthquake. (Courtesy of Hanshin Expressway Public Corporation.)
