Moehle, J.P., Eberhard, M.O. "Earthquake Damage to Bridges."
Bridge Engineering Handbook.
Ed. Wai-Fah Chen and Lian Duan
Boca Raton: CRC Press, 2000

Earthquake Damage to Bridges

Jack P. Moehle

Marc O. Eberhard

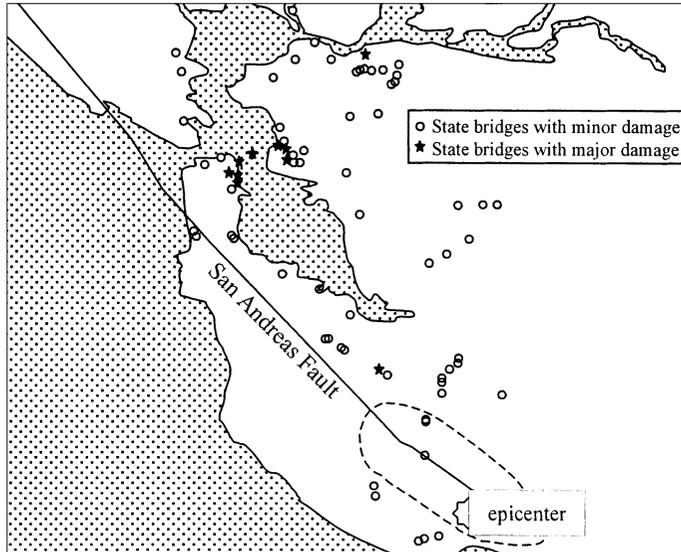
The influence of site conditions on bridge response became widely recognized following the 1989 Loma Prieta earthquake. [Figure 34.1](#) plots the locations of minor and major bridge damage from the Loma Prieta earthquake [16]. With some exceptions, the most significant damage occurred around the perimeter or within San Francisco Bay where relatively deep and soft soil deposits amplified the bedrock ground motion. In the same earthquake, the locations of collapse of the Cypress Street Viaduct nearly coincided with zones of natural and artificial fill where ground shaking was likely to have been the strongest ([Figure 34.2](#)) [10]. A major conclusion to be drawn from this and other earthquakes is the significant impact that local site conditions have on amplifying strong ground motion, and the subsequent increased vulnerability of bridges on soft soil sites. This observation is important because many bridges and elevated roadways traverse bodies of water where soft soil deposits are common.

FIGURE 34.1 Incidence of minor and major damage in the 1989 Loma Prieta earthquake [modified from Zelinski, 16].

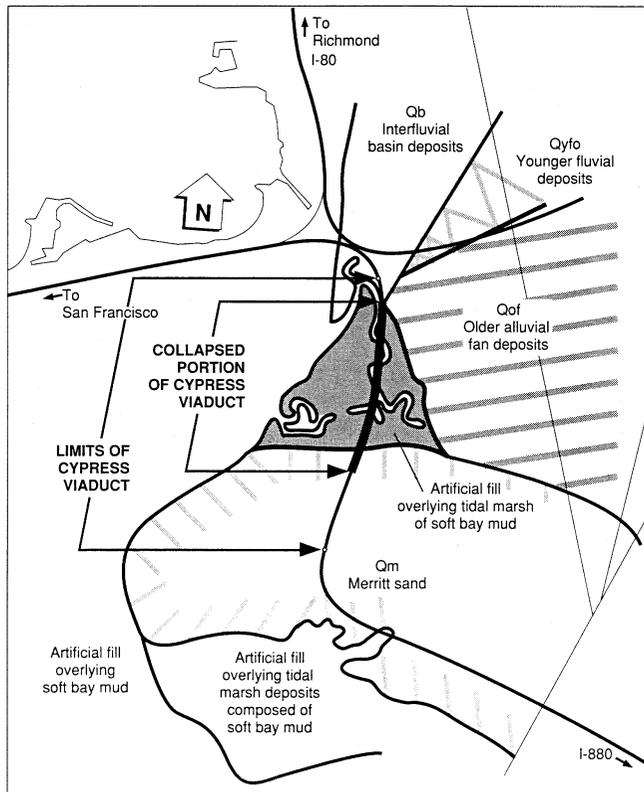
During the 1995 Hyogo-Ken Nanbu (Kobe) earthquake, significant damage and collapse likewise occurred in elevated roadways and bridges founded adjacent to or within Osaka Bay [2]. Several types of site conditions contributed to the failures. First, many of the bridges were founded on sand-gravel terraces (alluvial deposits) overlying gravel-sand-mud deposits at depths of less than 33 ft (10 m), a condition which is believed to have led to site amplification of the bedrock motions.

FIGURE 34.2 Geologic map of Cypress Street Viaduct site. (Source: Housner, G., Report to the Governor, Office of Planning and Research, State of California, 1990.)
