Yashinsky, M. "Earthquake Damage to Structures"  
*Structural Engineering Handbook*.  
Ed. Lian Duan  
Boca Raton: CRC Press LLC, 2001

# Earthquake Damage to Structures

Mark Yashinsky  
*Caltrans Office of  
Earthquake Engineering*

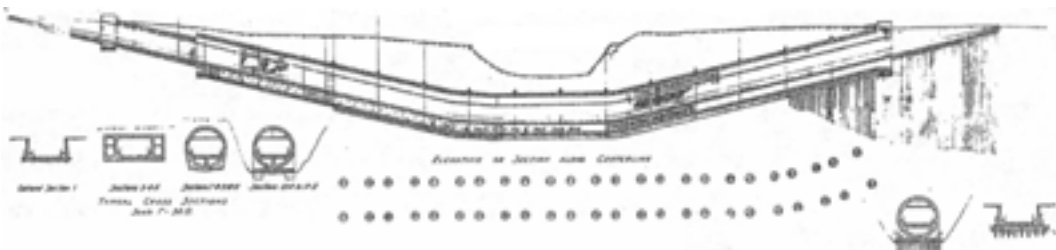
**FIGURE 30.8** Elevation view of the Posey Street Tube.

Structures supported on liquefied soil topple, structures that retain liquefied soil are pushed forward, and structures buried in liquefied soil (such as culverts and tunnels) float to the surface in the newly buoyant medium. The Webster and Posey Street Tube Crossings are 4500-ft-long tubes carrying two lanes of traffic under the Oakland, CA estuary. The Posey Street Tube was built in the 1920s (Figure 30.8), while the Webster Street Tube was built in the 1960s (Figure 30.9). They are both reinforced concrete

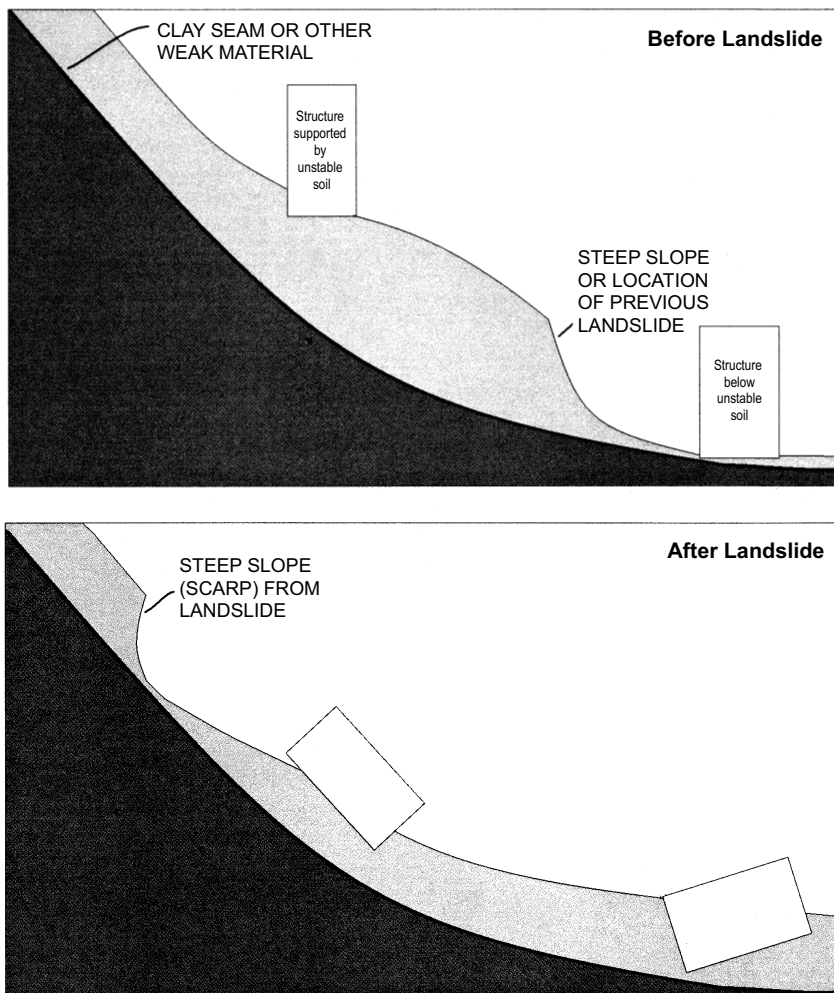
FIGURE 30.12 Diagram showing typical features of landslides.

When a steeply inclined mass of soil is suddenly shaken, a slip-plane can form, and the material slides downhill. During a landslide, structures sitting on the slide move downward and structures below the slide are hit by falling debris (Figure 30.12). Landslides frequently occur in canyons, along cliffs and mountains, and anywhere else that unstable soil exists. Landslides can occur without earthquakes (they often occur during heavy rains, which increase the weight and reduce the friction of the soil), but the number of landslides is greatly increased wherever large earthquakes occur. Landslides can move a few inches or hundreds of feet. They can be the result of liquefaction, weak clays, erosion, subsidence, ground shaking, etc.

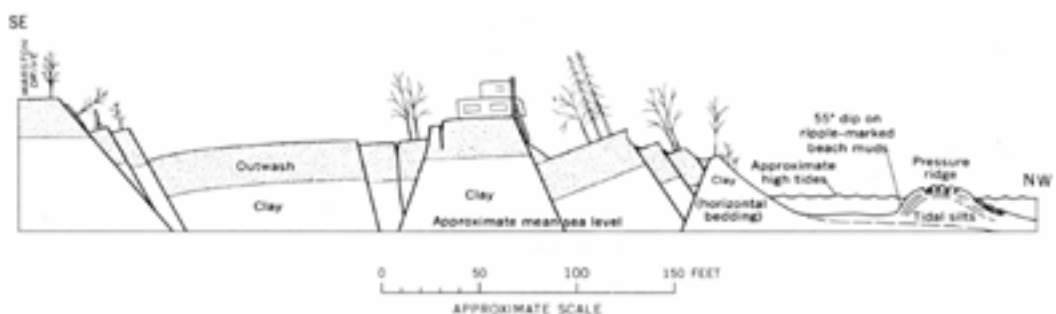
One of the best known and largest landslides occurred at Turnagain Heights in Anchorage during the 1964 Great Alaska earthquake. The area of the slide was about 8500 ft wide by 1200 ft long. The average drop was about 35 ft. This slide was complex, but the primary cause was the failure of the weak clay layer and the unhindered movement of the ground down the wet mud flats to the sea. [Figures 30.16](#) and [30.17](#) provide a section and plan view of the slide. The soil failed due to the intense shaking, and the whole neighborhood of houses, schools, and other buildings slid hundreds of yards downhill, many remaining intact during the fall ([Figure 30.18](#)).

FIGURE 30.16 Section through eastern part of Turnagain Heights slide. (Courtesy of the National Academy of Sciences [8].)

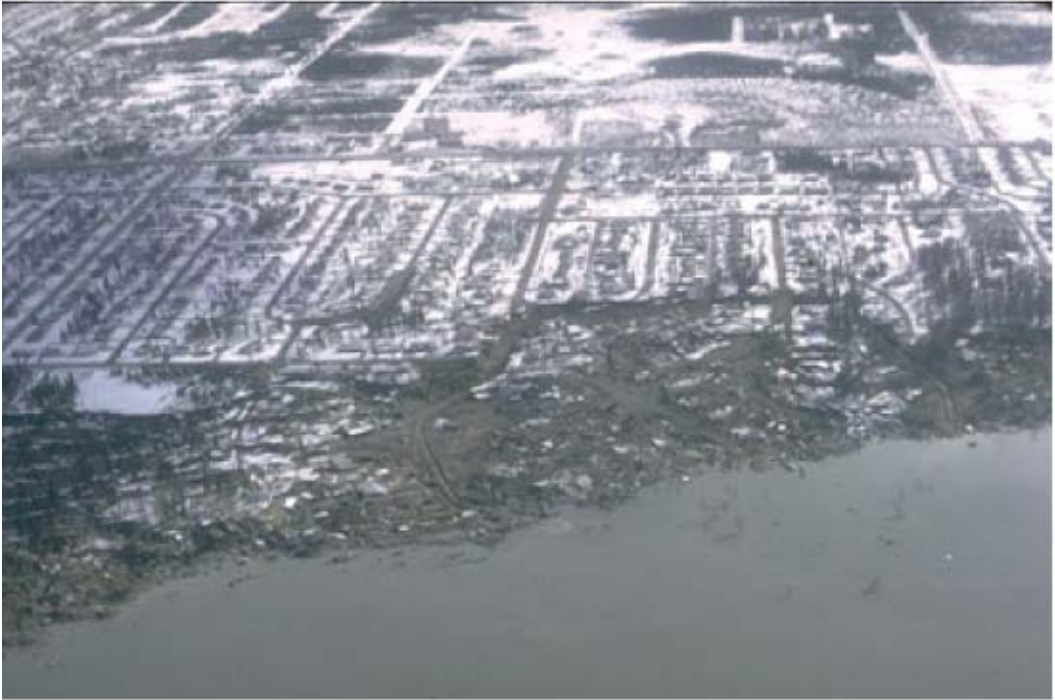
FIGURE 30.17 Aerial view of Turnagain Heights slide. (Courtesy of the Steinbrugge Collection, Earthquake Engineering Research Center, University of California, Berkeley.)

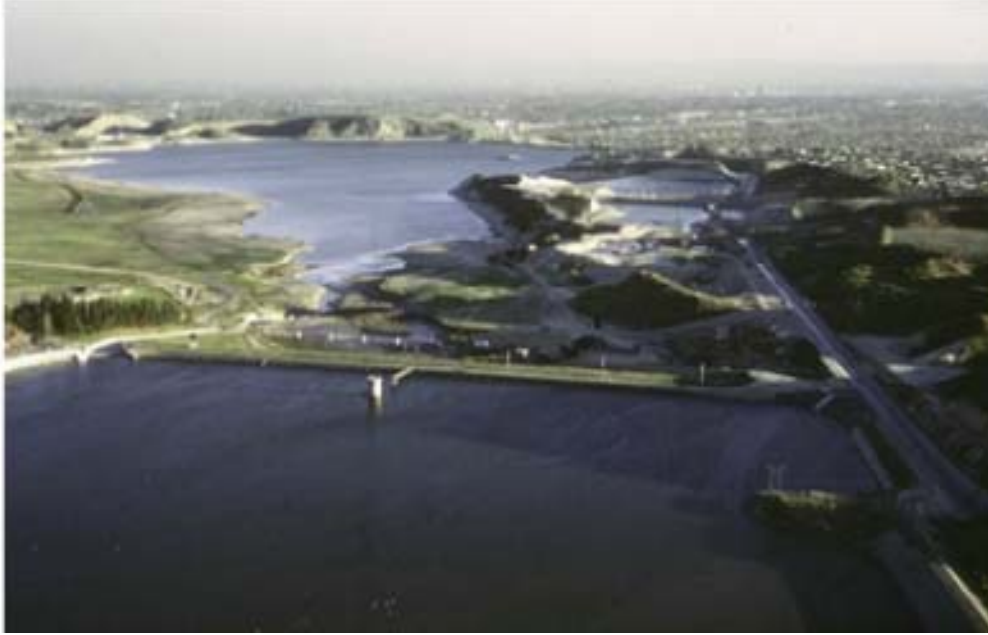
The Lower San Fernando Dam for the Van Norman Reservoir was also severely damaged during the 1971 San Fernando earthquake. It was fortunate that water levels were low, as the concrete crest on this earthen dam collapsed due to a large landslide along both the upstream (Figure 30.21) and downstream (Figure 30.22) faces. Considering the vulnerability of thousands of residences in the San Fernando Valley below (Figure 30.23), a dam failure can be extremely costly in terms of human lives and property damage.

**FIGURE 30.23** Aerial view of Lower San Fernando Dam and San Fernando Valley. (Courtesy of Steinbrugge Collection, Earthquake Engineering Research Center, University of California, Berkeley.)

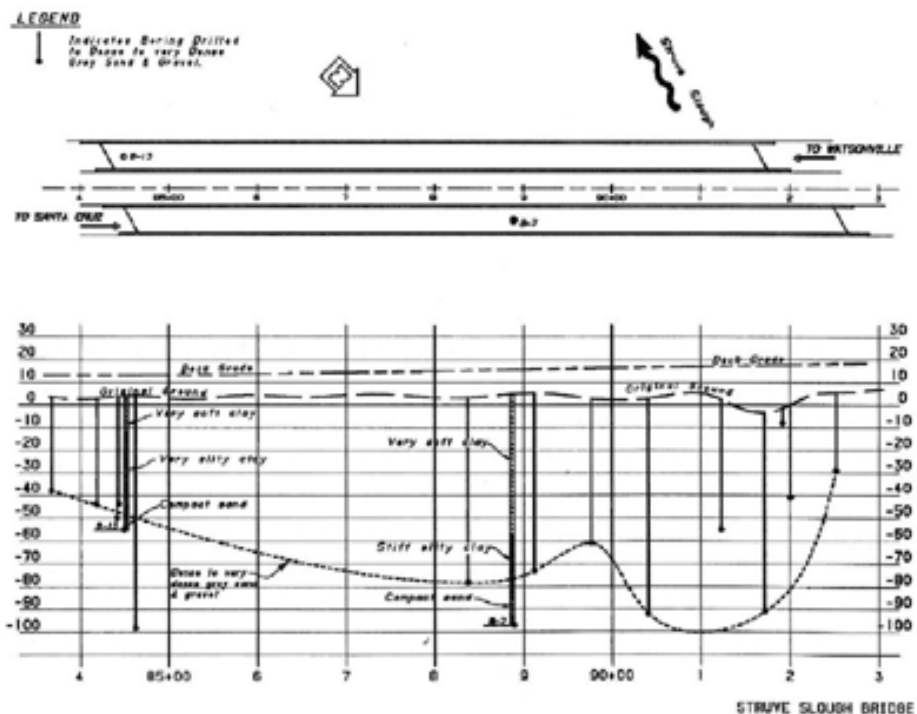
The problems encountered at soft clay sites include amplification of the ground motion as well as vigorous soil movement, both of which can damage foundations. Several bridges suffered collapse during the 1989 Loma Prieta earthquake due to the poor performance of weak clay. Two parallel bridges were built in 1965 to carry Highway 1 over Struve Slough near Watsonville, CA. Each bridge was 800 ft long with spans ranging from 80 to 120 ft. The superstructures were continuous for several spans with transverse hinges located in spans 6, 11, and 17 on the right bridge and in spans 6, 11, and 16 on the left bridge (they are both 21-span structures). Each bent was composed of four 14"-diameter concrete piles extending above the ground into a cap beam acting as an end diaphragm for the superstructure. The surrounding soil was a very soft clay ([Figure 30.24](#)). The bridges were retrofit in 1984 by adding cable restrainers to tie the structure together at the transverse hinges.

FIGURE 30.24 Soil profile for Struve Slough bridges.

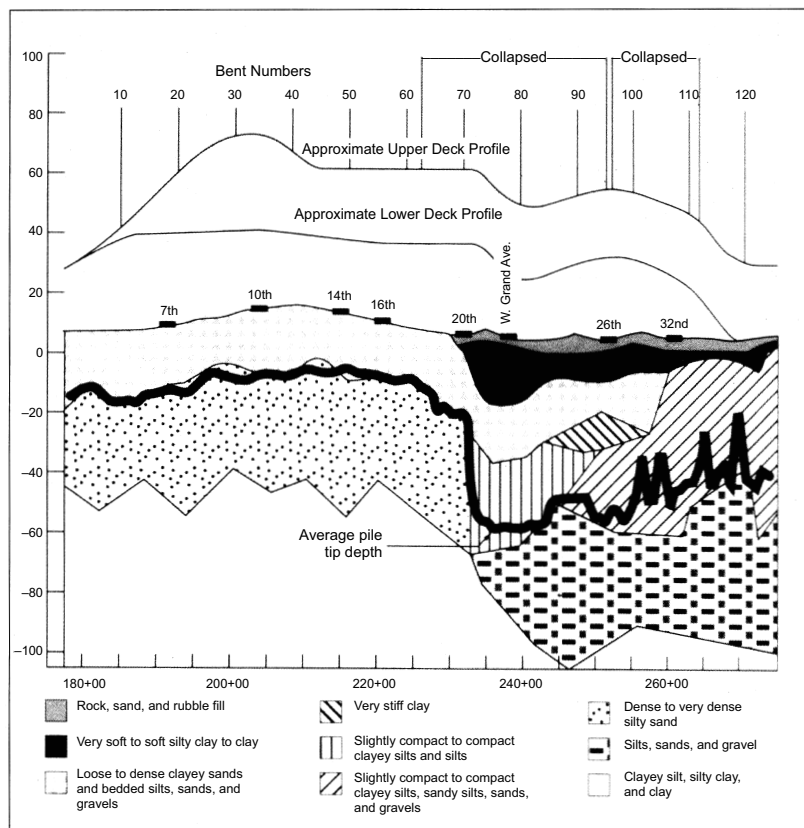
analysis for this long, complicated structure. The northern two thirds of the Cypress Street Viaduct was on Bay mud and had 50-ft piles, while the southern third was on Merritt sand with 20-ft piles ([Figure 30.27](#)).

**FIGURE 30.27** Geology of Cypress Street viaduct site [4].

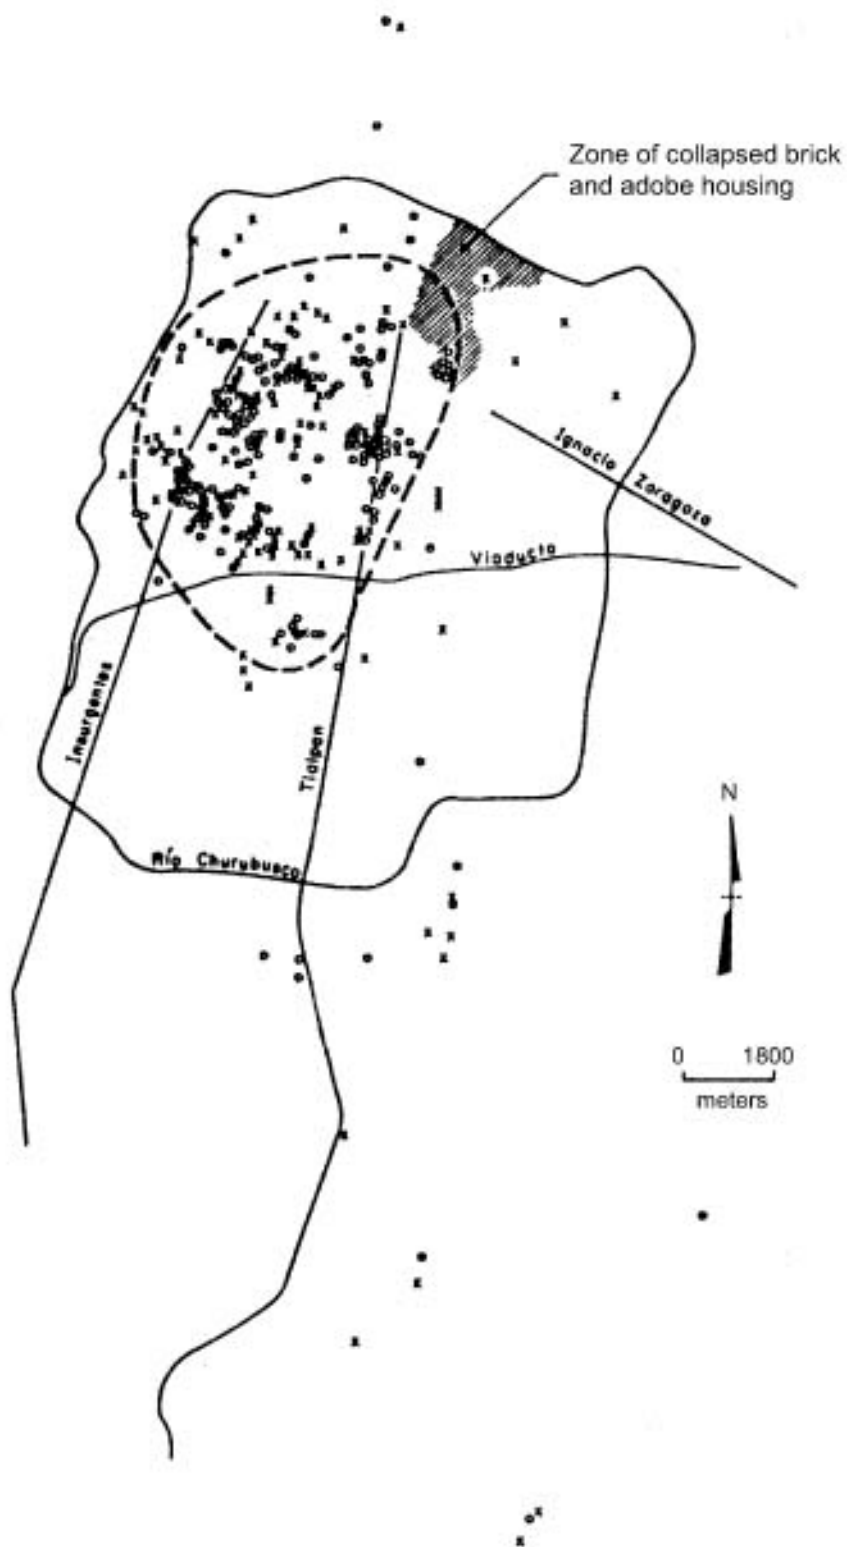
**FIGURE 30.30** Locations of building damage at Old Lake Bed in Mexico City. (Courtesy of EERI [2].)

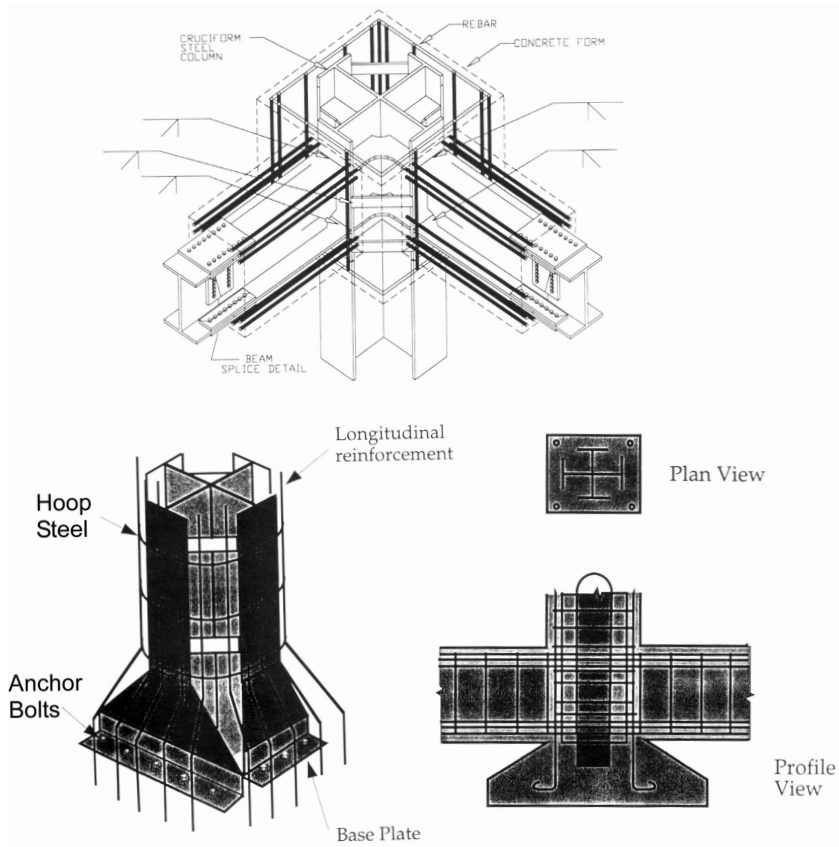
A soft story, however, does not always occur on the bottom floor. During the 1995 Kobe, Japan earthquake, many tall buildings had mid-story damage, often due to designing the upper floors for a reduced seismic load. Most buildings in Japan are either built of reinforced concrete (RC) or of steel and reinforced concrete (SRC). These SRC buildings, when correctly designed, provide a great deal of ductility and more fire protection during large earthquakes. However, the design practice in Japan was to discontinue either the reinforced concrete or the steel above a certain floor. [Figure 30.38](#) shows typical details used in SRC buildings. [Figure 30.39](#) shows a ten-story SRC building where the third story collapsed during the 1995 Kobe earthquake.

**FIGURE 30.38** Examples of steel and reinforced-concrete (SRC) construction. (Courtesy of NIST [9].)

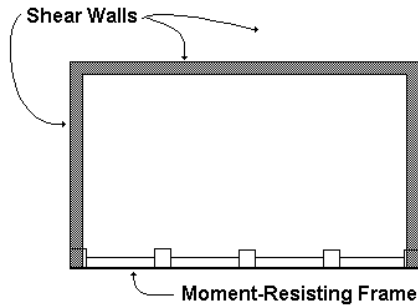
Curved, skewed, and eccentrically supported structures often experience a torsional moment during earthquakes. A nine-story building in Kobe, Japan, consisted of shear walls along three sides and a moment-resisting frame on the fourth (east) side ([Figure 30.40](#)). Shaking during the 1995 Kobe earthquake caused a torsional moment in the building. The first-story columns on the east side failed in shear, the building leaned to the east ([Figure 30.41](#)), and it eventually collapsed ([Figure 30.42](#)).

**FIGURE 30.40** Plan view of nine-story steel and reinforced-concrete (SRC) building in Kobe.

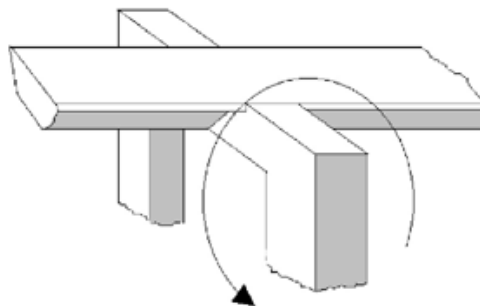
suffered severe torsional damage ([Figure 30.46](#)). As one member of a bridge goes into flexure it can create large torsional moments in adjacent members. For instance, flexure in the columns of outrigger bents causes large torsional moments in the bent cap ([Figure 30.47](#)). All of these examples reinforce the idea that most structures require consideration of all three translations and rotations.

**FIGURE 30.47** Column flexure causing torsion in the bent cap.

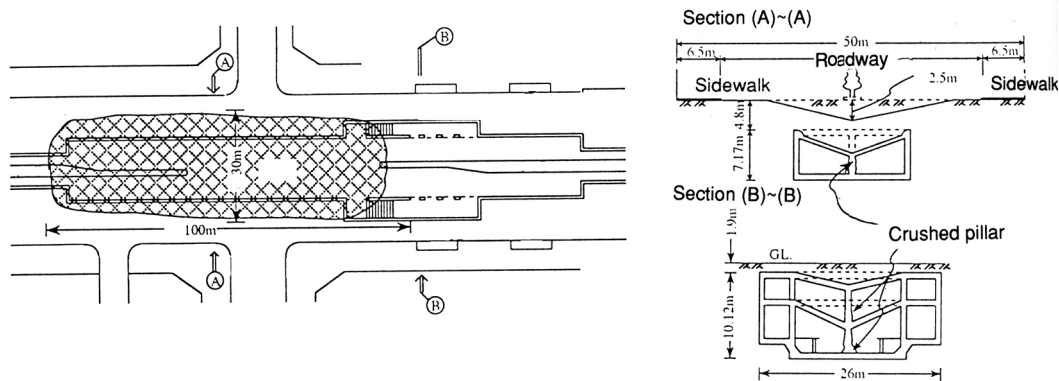
The Dakkai subway station in Japan is a two-story, underground, reinforced-concrete structure. It was constructed by removing the ground, building the structure, and then covering it (the-cut-and-cover method). During the 1995 Kobe earthquake, the center columns on both levels suffered a combination of flexural and compression damage that caused both roofs to collapse along with a roadway that ran above the station (Figure 30.52). Figure 30.53 shows the rather slender center columns at the lower level after the earthquake. The columns had insufficient transverse reinforcement at the location of maximum moment. The transverse reinforcement broke as the columns were displaced, allowing the longitudinal reinforcement to buckle and the concrete to fall out of the column.

**FIGURE 30.52** Plan and section drawings of the Dakkai Subway Station after the Kobe earthquake. (Courtesy of Japan Society of Civil Engineers [5].)
